## Incident Investigation Report

1. Location & Date of Incident: Penrith, Australia (O-I) – July 15, 2014
2. Personnel involved: Mark Randle, Jason Tomkins, Chris Barker, Kitirat Kaenthao, Rob Ward, David Cobane
3. Incident as reported:

#### Incident Report-Drain at OI Penrith Australia July 2014

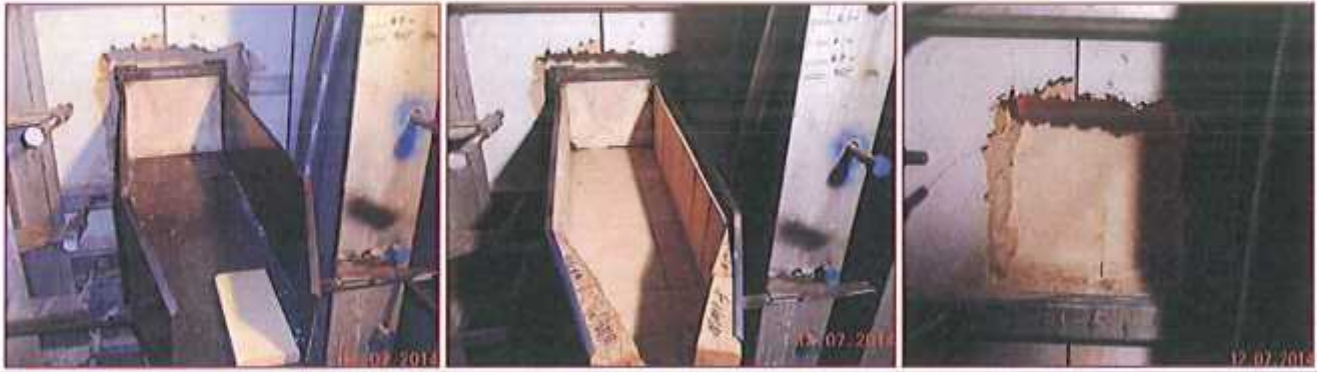
Sidewall insulation removal – cover tile installation into the trough – lining of the trough and installation

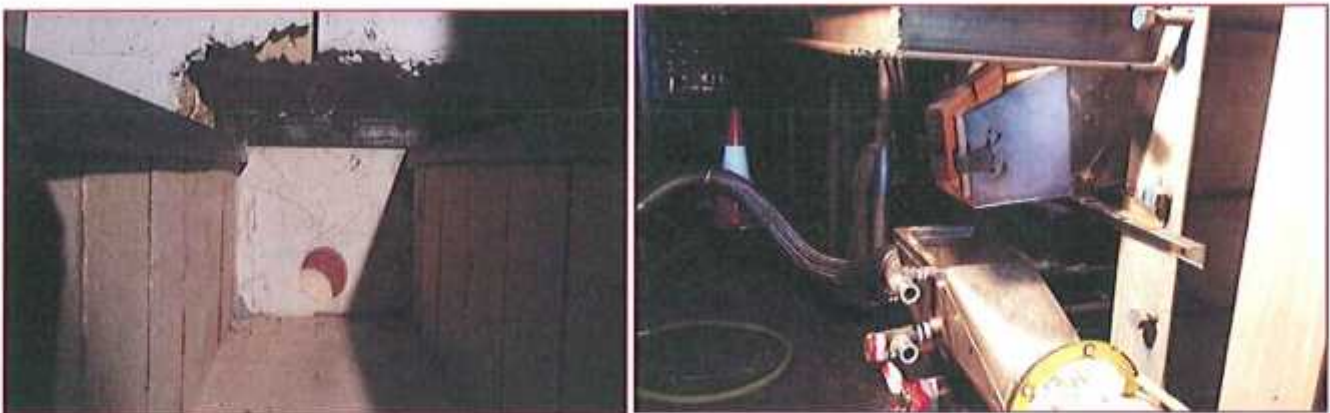
Drilled cover tile and alignment with the water-cooled receiver at the designated tapping point and location

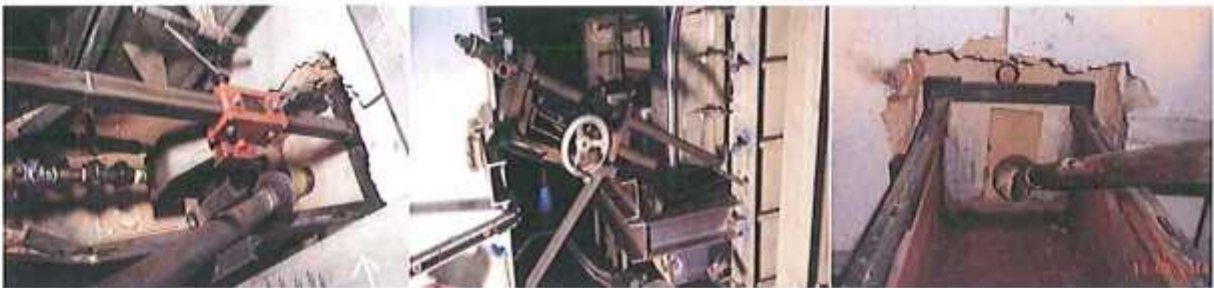
Drilling of the furnace sidewall – set up of the safety ball – hole drilled and a safety brick in front of the hole

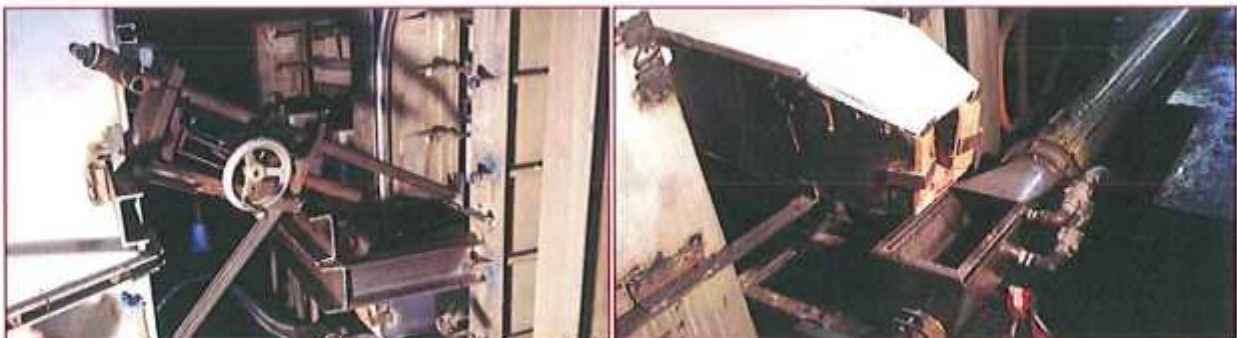
Supporting steel drill frame removed giving an obstruction free pathway to the tapping point and location

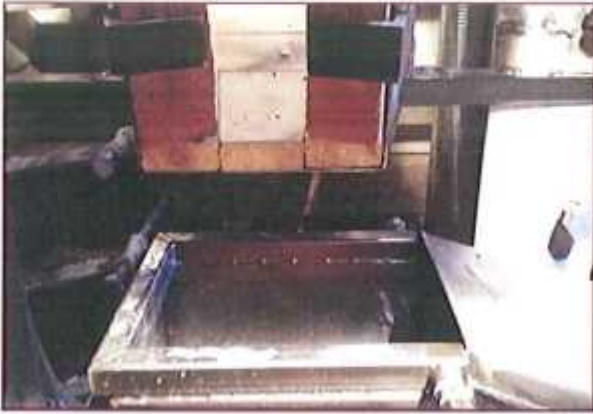
Drop height

- As you can see the drop height between the trough and receiver was only approx. 6" in height, we had discussed prior with the plant about dropping this draining hole location, and putting in a banana piece to lower the elevation, the plant did not want to do this and accepted that the height and elevation was acceptable.

- There are always elements of risk and danger associated with such a close drop height from the trough to the receiver.
- Tuesday morning the 15<sup>th</sup> of July 2014 all Hotwork crew members were on site at the plants request of 6am, the nightshift crew completed their plant inductions, and proceeded to the tapping site, the plant had removed the furnace batch chargers, and were draining the forehearth and working end before we could start the glass drain, there was one dedicated front end loader driver that was busy in the basement and until he was free we could not start, meanwhile we all got our safety gear on, had 2 lances prepared, and discussed between ourselves as a group who would be responsible for what part during the opening of the hole. The boilermakers were on standby with equipment to assist on either lancing the hole if required, or providing heating via a gas torch. Hotwork had discussed prior with the plant and boiler makers that a clear line of communication was required at all times between, the person at the API pit watching the levels and checking on the pump status, a person at the 2<sup>nd</sup> booster pump to monitor its operational activities, and a 3<sup>rd</sup> person at the hotwork tapping site to communicate with us directly if we needed any of the pumps to be shut down in an emergency, all of these people required radio communication between them.

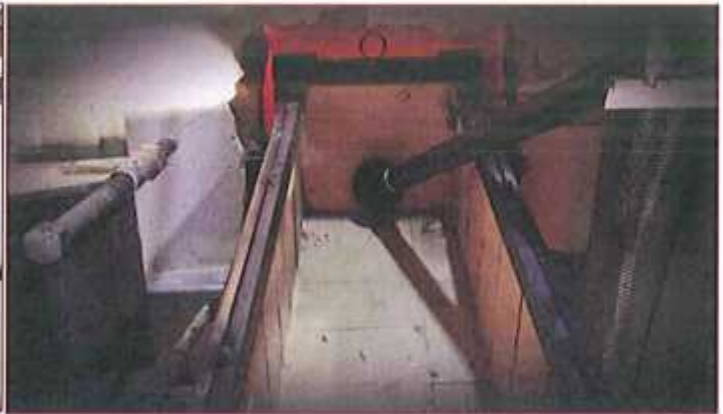
Water cooled shut off ball in place.

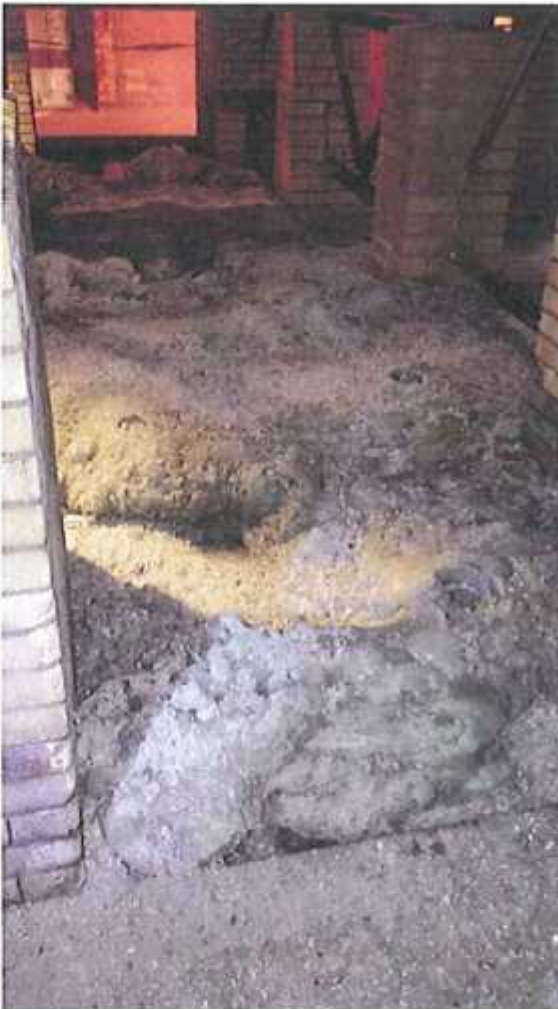
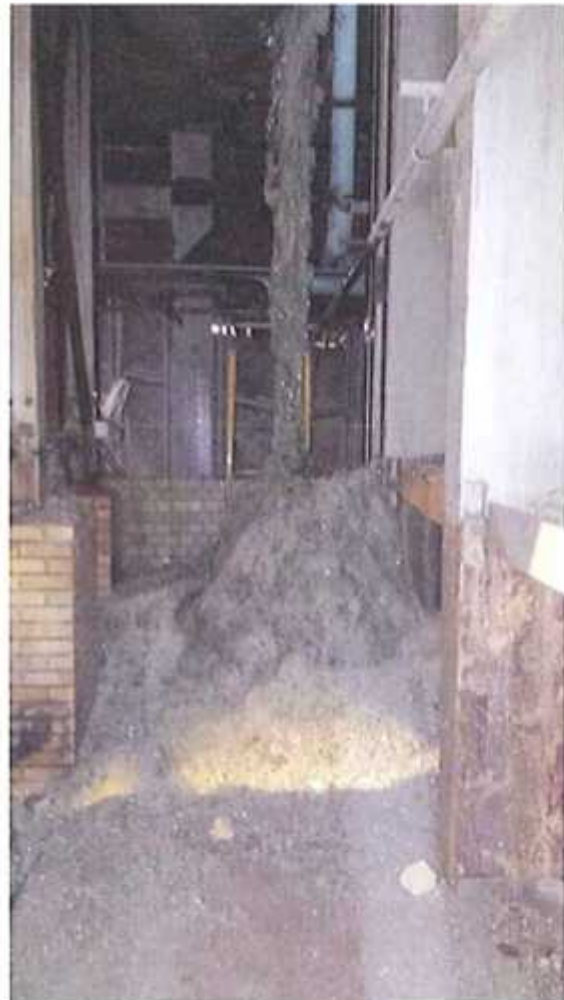
This event -- from the time the drain was started until the crew stopped the flow of glass -- lasted a total of two and a half hours, and it is estimated by the client that 30 tons of glass was spilled into the basement.

4. Injuries: None
5. Property damaged: A new concrete floor located below the tank was damaged and had to be replaced.
6. Remedial Actions:
  - 1<sup>st</sup> Event: Crew took action to get the pump water shut off after the drain pipe become blocked and used water lances and fire hoses to freeze the glass before it completely drained itself into the basement.

Glass leaked into basement

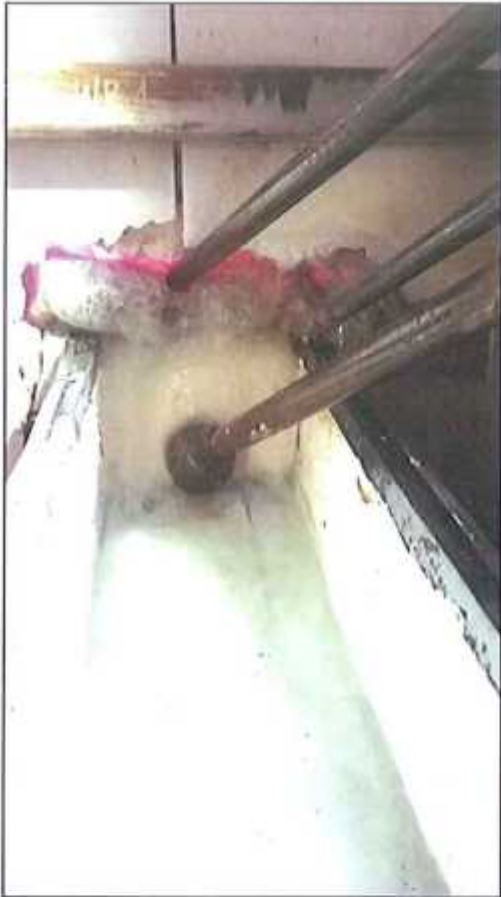
The following day, the crew restarted the drain without incident. After draining glass for approximately six hours, the crew observed glass oozing above the cover tile. Steve Town of O-I was consulted and he instructed that the drain be shut down. The leaking glass was assessed to be a safety hazard.

9. Situational Assessment (2<sup>nd</sup> Event):
- a. Root Cause: Glass leakage between the cover tile and the sidewall block.
  - b. Contributing Factors:

- i. Large water volumes applied on the previous day may have caused contraction of the cover tile, creating a thin glass path between the cover tile and sidewall block.

- ii. Vibration on the previous day due to the jackhammer and cleanup process may have caused a separation between the cover tile and sidewall block.

- iii. Removal and replacement of the bricks within the trough during the second setup may have allowed for a loosening of the securing force between the trough lining and the cover tile.

Assessment made to shut off glass on second day

- i. New Standard Operating Procedure for when a cover tile and trough experience a major upset: Clear the receiver → Mine the glass from the trough → Assess damage → If damage done to splits, replace → If splits are replaced, inspect the cover tile and if any movement is noted, remove, clean and replace → If no movement is noted, wedge the cover tile in tightly using splits, steel work and caulk around any exposed edges → To replace cover tile, drill into the sidewall block about 3", freeze the glass, and while holding a water lance against the glass, cool the cover tile and remove.

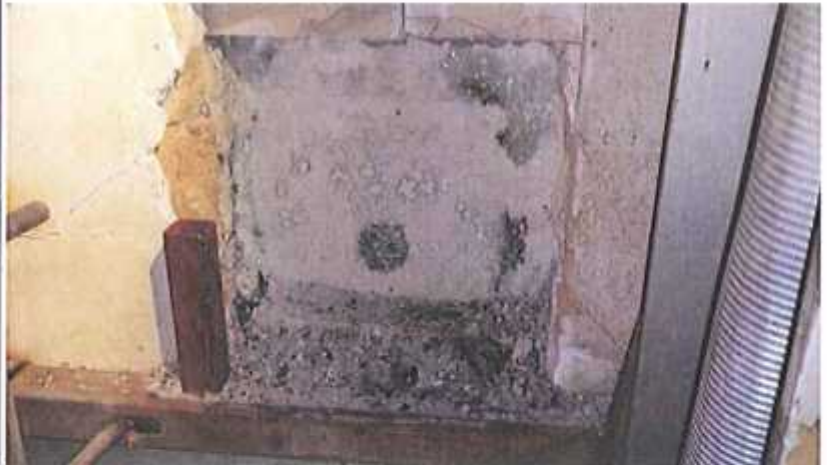
Sidewall with cover tile removed
