On Friday, a follow up meeting was held at Certainteed HQ to discuss the failed glass furnace drain in Athens and also the accident involving Karl Burger. Here's some feedback on each issue and corrective actions for the future.

A.) The Drain

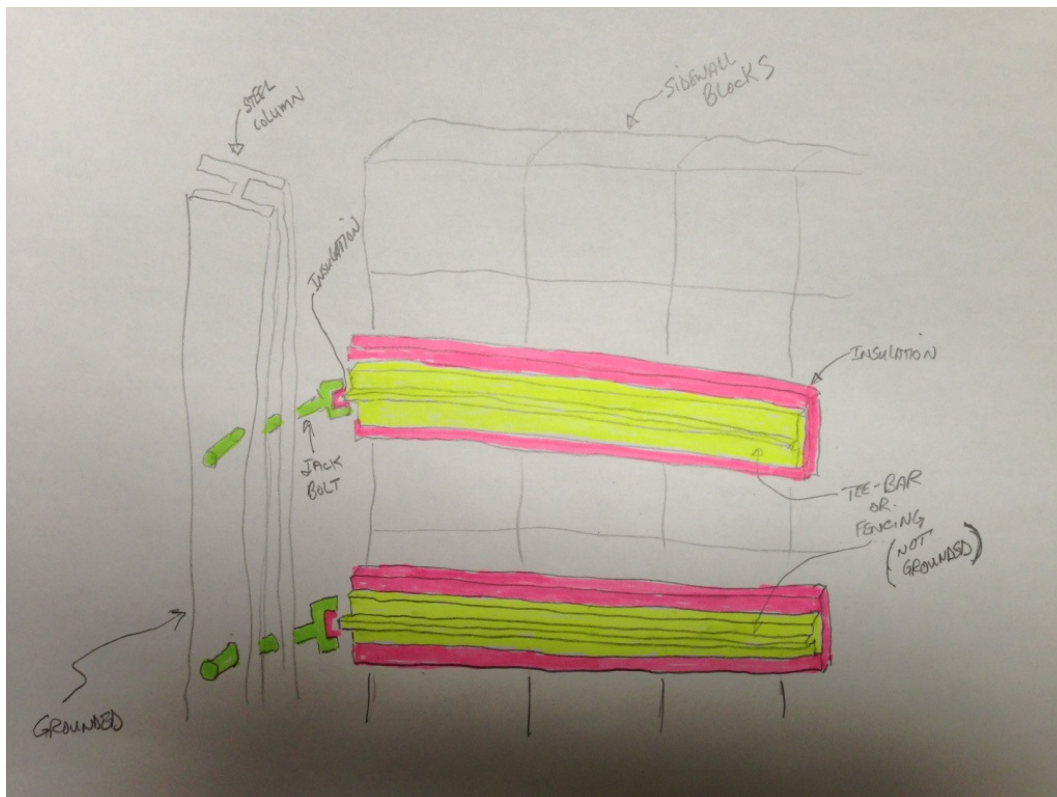
The furnace has "tee bars" (or furnace fencing) holding the sidewall blocks in place. There is insulating material between the tee bars and the furnace blocks. The tee bars are held in place by jackbolts threaded thru the furnace buckstays. The jackbolts contact the tee bars where a "saddle" goes over the ridge of the tee bar. Inside the saddle, there is insulating material to prevent the tee bar from going to ground via the jackbolt. So by design, the tee bars (or fencing) are electrically isolated from the rest of the steel structure.

Certainteed engineers believe that the Hotwork trough should not be connected to grounded steel. They recommend using the electrically isolated tee bars and/or using some type of insulated connection if it is necessary to secure the trough to grounded steel structure. Using a C-Clamp with insulating material is one possibility.

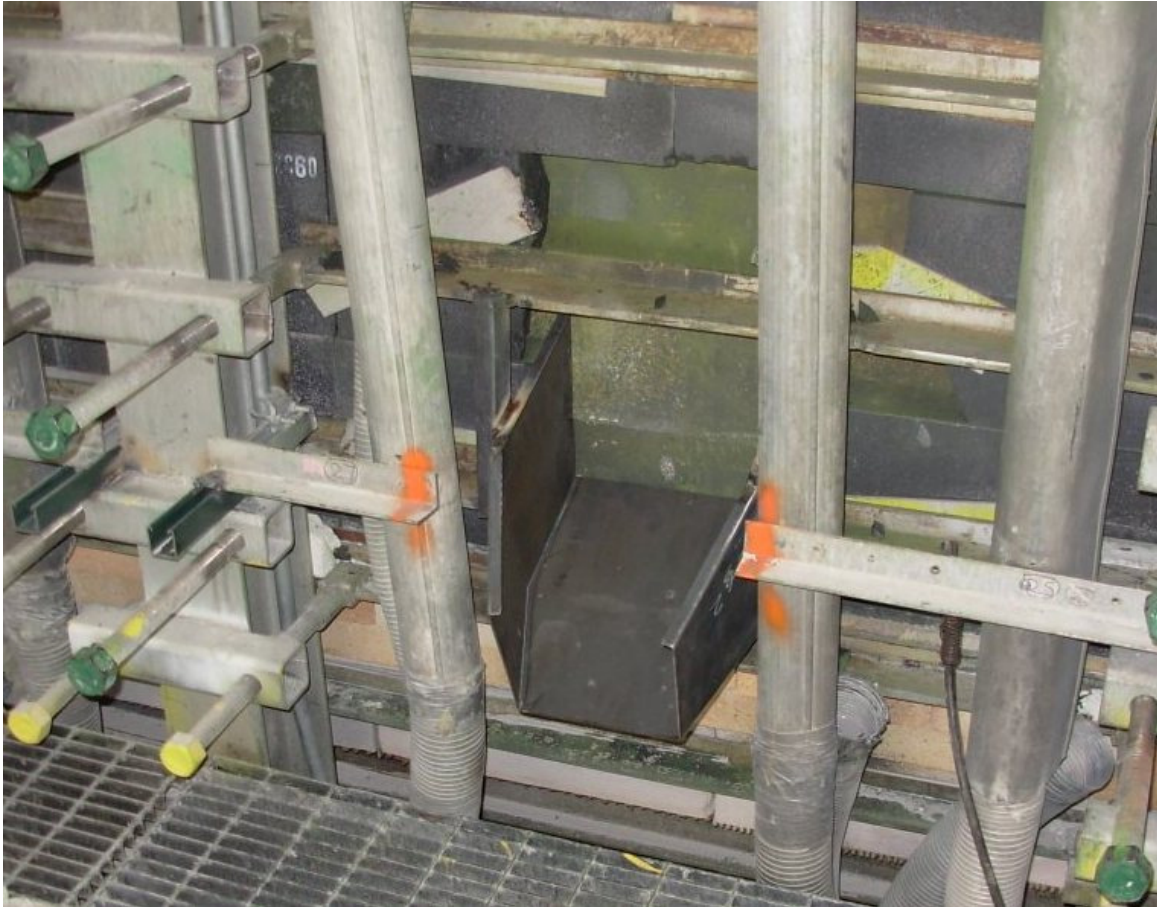
The picture below is the 2006 Athens drain setup which they considered proper. As you can see, the trough was connected to a vertical angle iron that was attached to two furnace tee bars. No connection was made to grounded steel structure.
