We have had issues with four drain pumps recently and we have learned a lot by investigating each of these issues. The information below is provided so that everyone can gain a clear understanding of how these pumps work and what may be going on during operation in the field.

Some background information on our drain pumps. We have two different capacities of pumps that we call medium and high pressure. Medium pressure pumps are our older variety and they are generally used on simple cold water downhill drains (pressurized supply from the client's system). The high pressure pumps are used for hot water recycled drains and any significant uphill or curved runs. Here's the pump list:

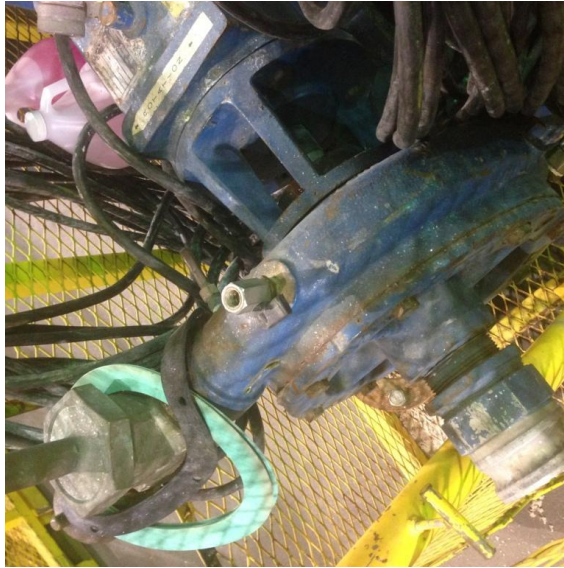
- v. If amps drop off and vibration occurs, field troubleshooting should determine whether the cause is a.) cavitation or b.) partial loss of prime
 - vi. The shop will look at the arrangement of the bleed valve (petcock also used for initial priming) to insure safety when trying to remove air bubbles from the pump housing during operation.

vii. If there is a systematic ingress of air, the source has to be corrected.

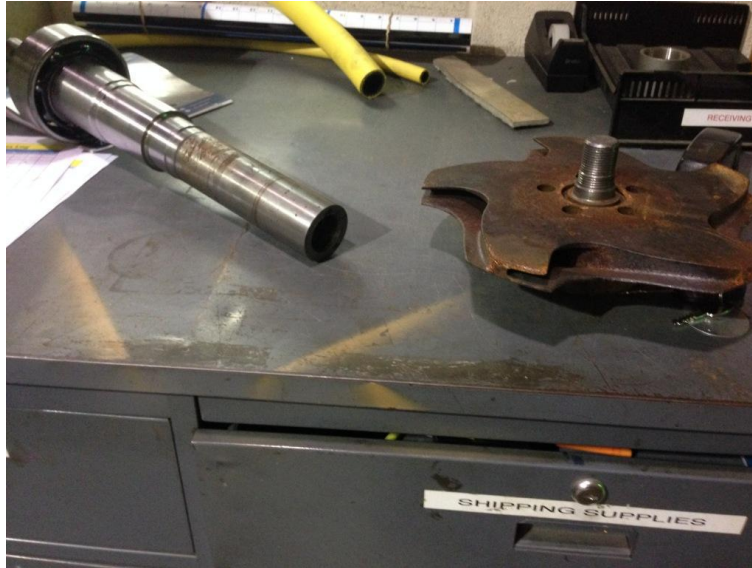
This photo is of the pump shaft and impeller after it was removed. The shaft is threaded on the inside and the impeller shaft is threaded on the outside. These two parts just screw together and in normal rotation, the force on the impeller from the fluid is causing the connection to be continuously tightened.

- d. In the first moments of operation after a complete rebuild, this pump was destroyed and it needed to be completely rebuilt once again.
- e. It turns out that this design of shaft/impeller assembly is very sensitive to reverse rotation. When the pump starts to turn backwards and then the power is stopped, the weight of the impeller wants to keep rotating and the shaft starts to slow down due to less inertia and friction in the bearings etc. This makes the impeller want to unscrew from the shaft.
- f. So it appears that this impeller was loosened from its shaft and eventually the threads stripped – either during the reverse operation or when rotated forward on the restart (after loosening).

- j. Conclusions:
 - i. This shaft design is susceptible to failure in the way the we operate (bump test)
 - ii. We will not buy anymore pumps of this shaft design

- iii. If we have another failure, we will replace the pump rather than rebuild it
 - iv. When this style pump has been rebuilt, the shop will test direction uncoupled for the first operation to insure that the first time it runs it is going forward

- v. We will work with the shop to experiment with the amount of torque as a way to reduce the risk of reverse rotation failure (or Loctite or a weld bead).

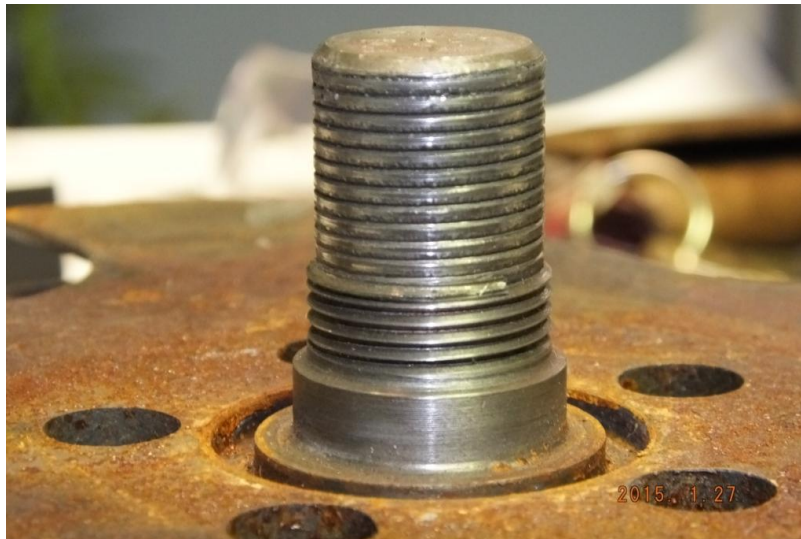
Here's a closer view of the threads on the impeller. The threads had been completely stripped for most of the shaft length.
