Last month I reported on an incident with the new Hansen style gas fittings. The bad news is that one inadvertently disconnected in the middle of a job. The good news is that the flapper valve in this fitting stopped the flow of gas and there was no release or fire. We have investigated the fittings involved in the incident and we returned them to the manufacturer for inspection. We have also simulated the same situation in the shop with compressed air. I believe that we now understand what may have happened.

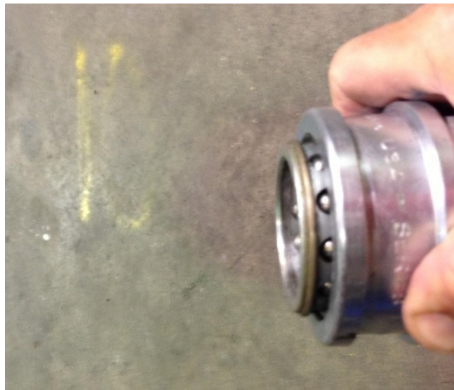
Female end of fitting with sleeve pulled back

The way this fitting works is that the male end of the fitting has grooves on its OD. When it is inserted into the female end of the fitting, the ball bearings fit down into the groove. When the sleeve on the female side slides forward, the ball bearings are held in place in the groove and the fitting can't come apart.

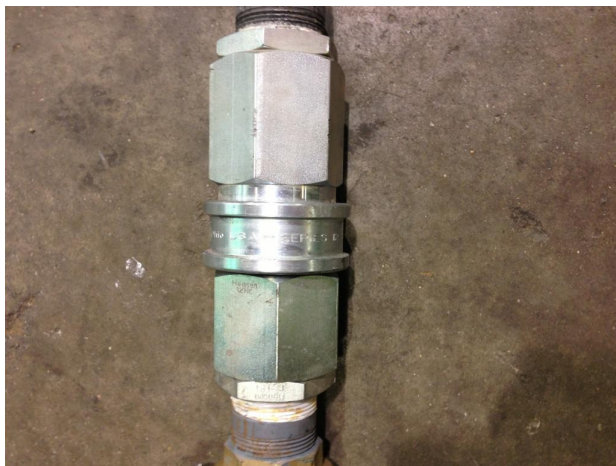
Properly mated and locked fitting.

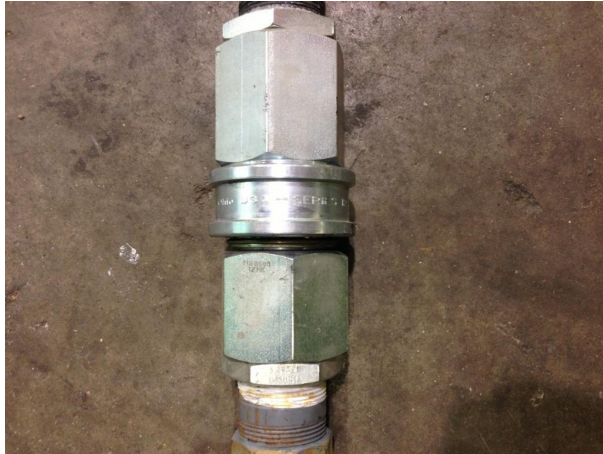
Fitting with sleeve partially retracted.

The manufacturer could find nothing wrong with the fitting that came apart. The only way that the coupling would disconnect was if the sleeve was pulled back. We experimented in the shop using 20 psi of compressed air. We found that it was possible for the connection to stay together while under 20 psi of pressure with the sleeve stuck partially pulled back as shown above. This condition could happen if a hose was properly connected and then dragged across a floor where the sleeve was pulled back by friction with the floor (or the sleeve was kicked, etc). It is a touchy condition where the sleeve will stick in the mostly retracted position but the coupling doesn't blow apart. When it is in this position, it doesn't take much vibration or jiggling before the connection lets loose.

We'll never know for sure what happened on this particular job but since the hose stayed in service for 5 days before blowing apart, I believe that somehow the sleeve was retracted as shown above. My suspicion is that some movement of the already coupled hose (drag on floor, across crack, etc) caused the sleeve to partially retract. With 20 psi gas, there wasn't enough pressure to immediately cause disconnect – some vibration, expansion/contraction, or other “final straw” caused it to let loose after 5 days.

The immediate corrective action is to put a zip tie on the connected fitting to prevent the sleeve from slipping back. We are also investigating with the manufacturer whether there is another way to secure the sleeve.

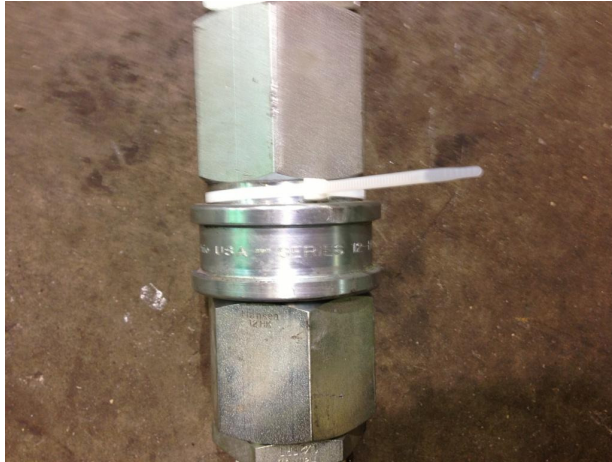
Zip tie to prevent inadvertent sleeve retraction.

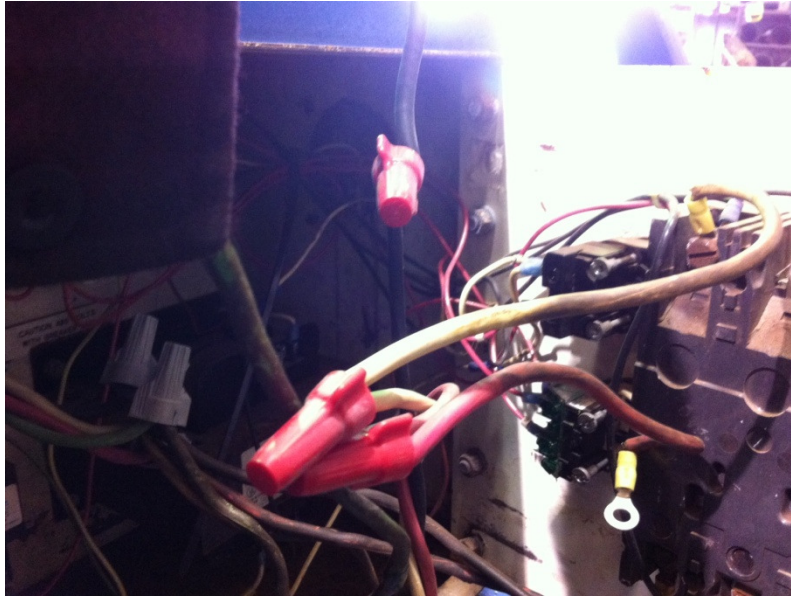
Recently we went to a jobsite and learned that they had a site rule prohibiting splices in 480v cables. The fan cables that we supplied were not long enough to reach the client's disconnect box so the client assigned their electricians to replace our fan cables with longer ones. The electricians did this work without oversight or supervision by Hotwork employees. When the fans came back to the shop, this condition was found inside our fan cabinet.

Rather than land the new wires on the terminal strips, the electricians cut off a short pigtail and made untaped wire nut splices inside our equipment. We don't consider this to be good workmanship and it is possible that these fans could have been sent back out to another job in this condition if not discovered in our shop. Whenever possible, you should try to monitor the work performed by plant electricians on our equipment. If there is a reason to suspect the workmanship, you should red tag the equipment for the shop to check when returned. We're not qualified electricians but we can observe and advise the ones who do work on our equipment. In this case they didn't want splices in their plant so they put them inside our equipment?!?!
