Recently we had a serious incident on a glass furnace drain. During the setup on an all electric (cold top) fiberglass furnace, the client noticed that we had welded a support from the bottom of the trough to some furnace steel work. He believed that this steel was not electrically isolated from the electrode current so he asked our crew lead to remove the support. Due to concerns over current leakage thru this steelwork, the brace was removed. The trough was welded at the top to furnace steelwork that the client believed was electrically isolated. An additional side support was cut free and re-attached with a C-clamp using insulating material.

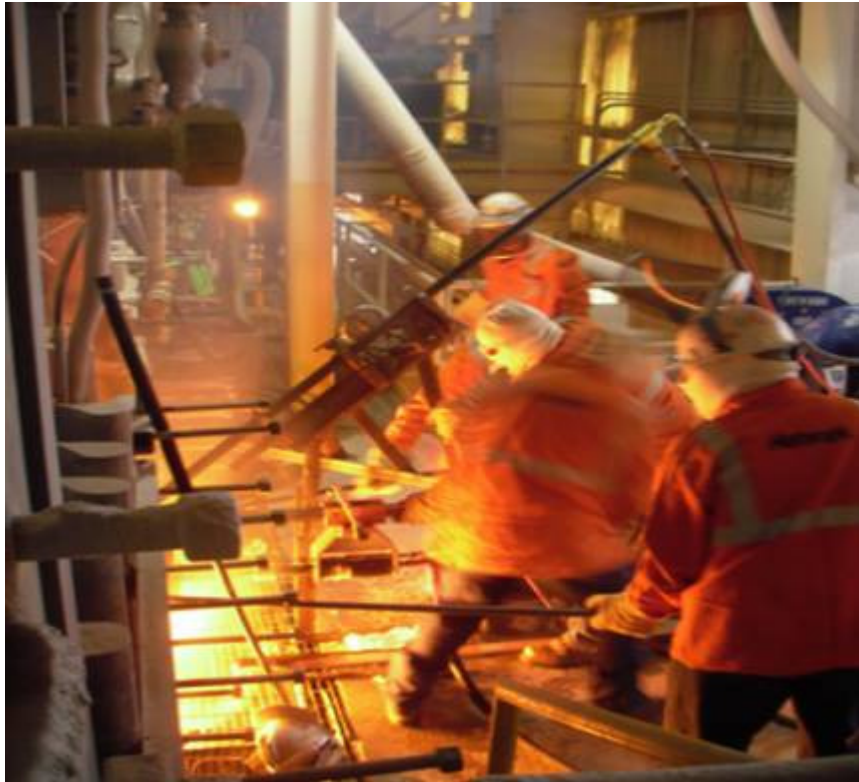
beginning.

Fighting the leak at the

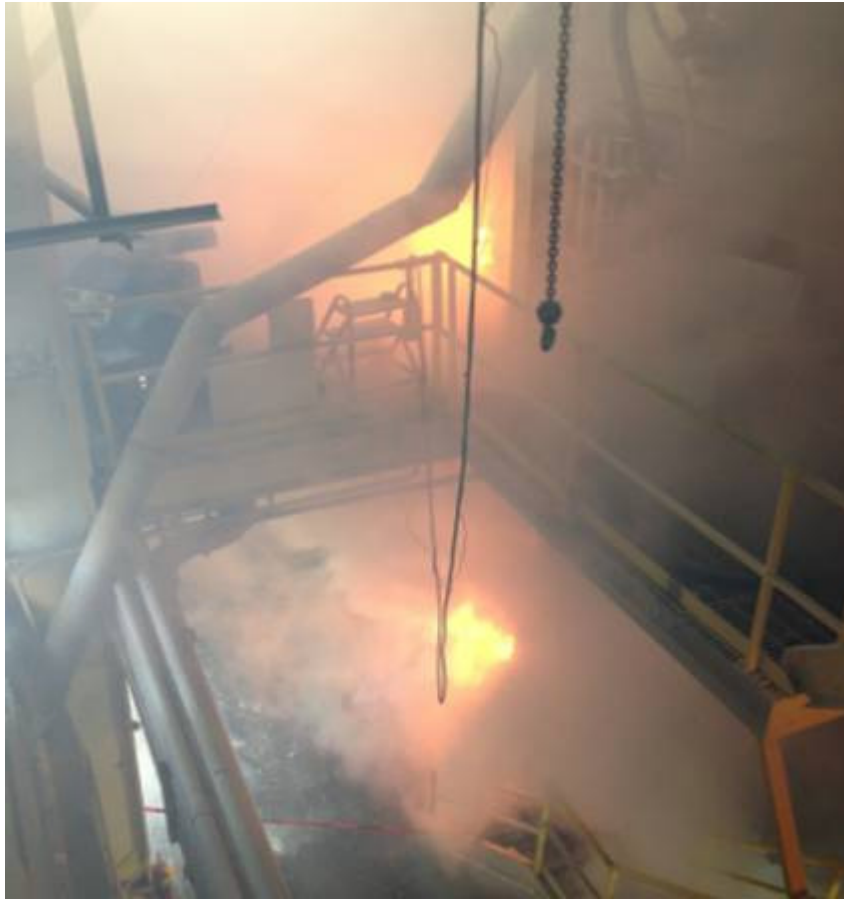
Leak in process.

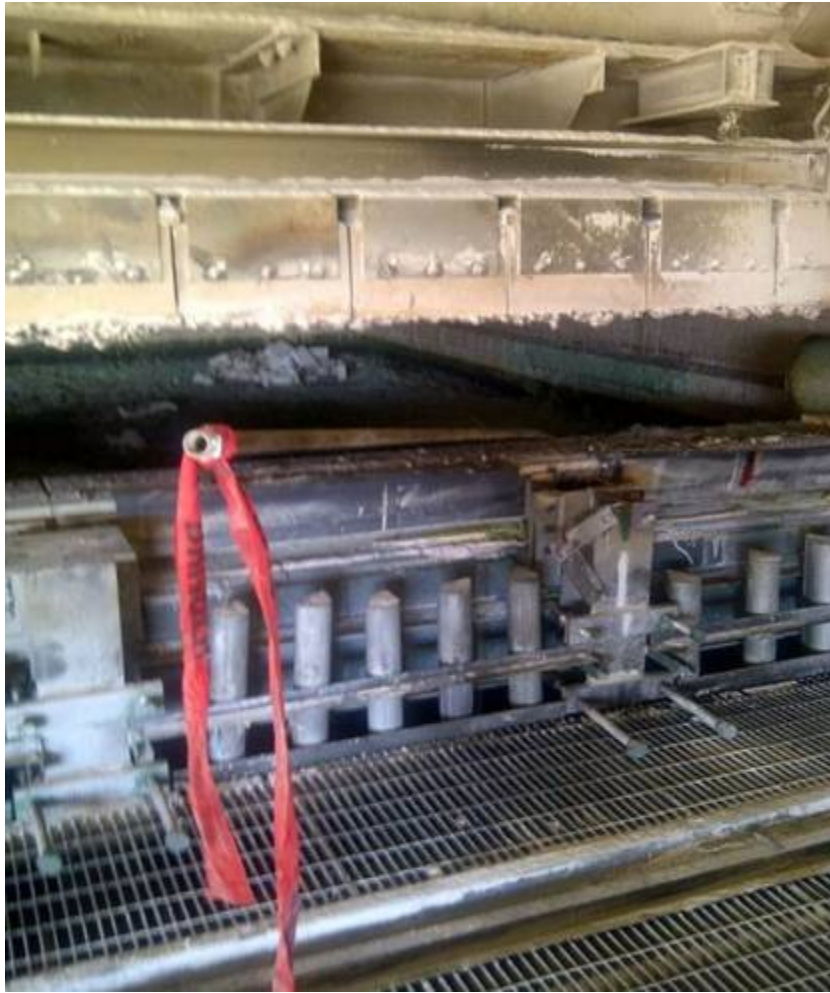
Lance inside furnace.

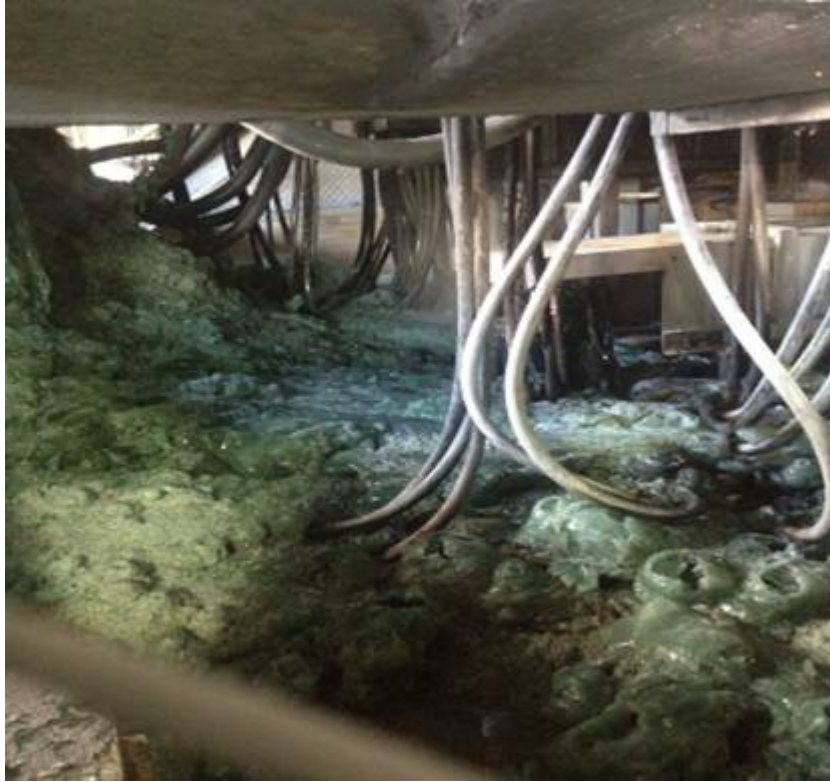
Leaked glass and electrode cables.
