Re: Hotwork Quotation No. 17775400
Glass Drain & Heatup with Expansion Control Supervision (ECS)
Of your Electric Glass Furnace
Drain Starting December 2nd, 2016
Heatup Starting February 2017

As you are aware, the glass furnace drain referenced in the above quotation was aborted on December 4th due to extraordinary conditions encountered during the attempted drain. This report is intended to document the conditions experienced and to further explain the decisions made on site.

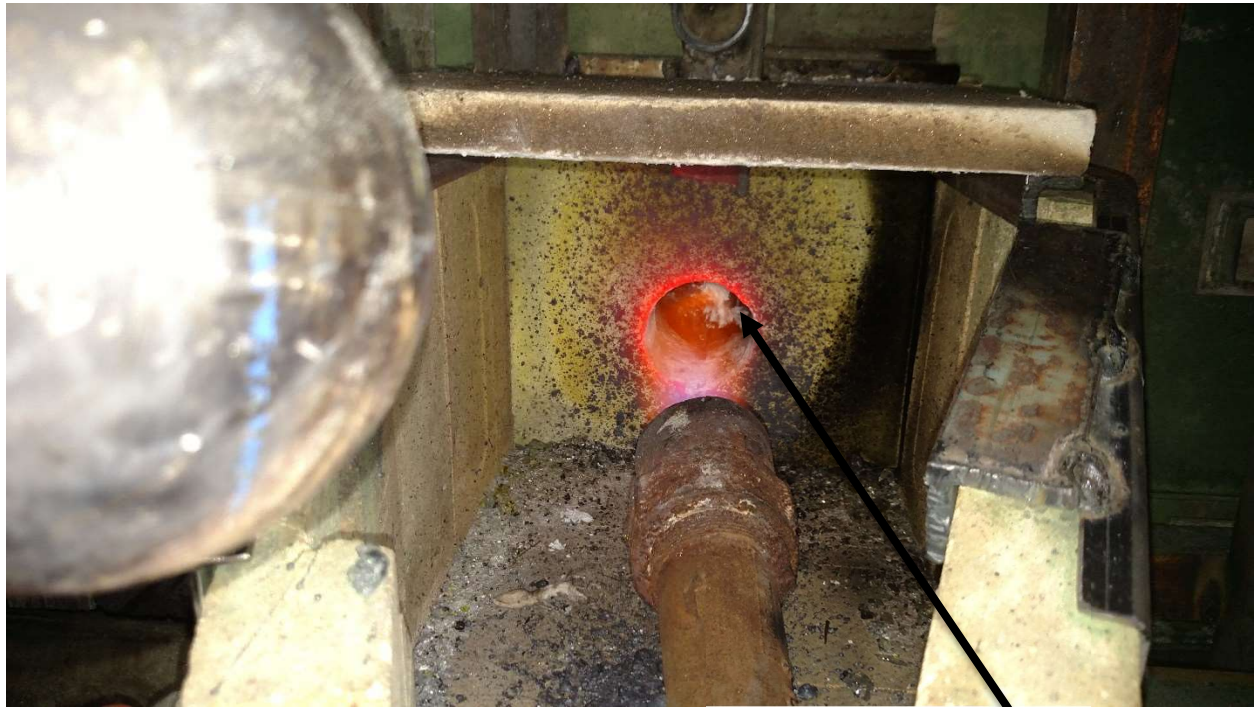
- Sunday December 4th, 2016:** Crew arrived at 5am. Upon removing the fiber balls the glass appeared to be dark still (cold). A torch was added to the hole at this point to try to heat the area locally from the outside. Some glass did dribble out from around the edges of the tile after heating it up with a torch, but just as quickly stopped. Hotwork crew members replaced the torch with a Hotwork burner, this action resulted in little to no results. Although some glass slumped in the hole.

Remains of the fiber balls, used to heat up the drain hole overnight. Cold glass still in the hole, being heated by a burner.

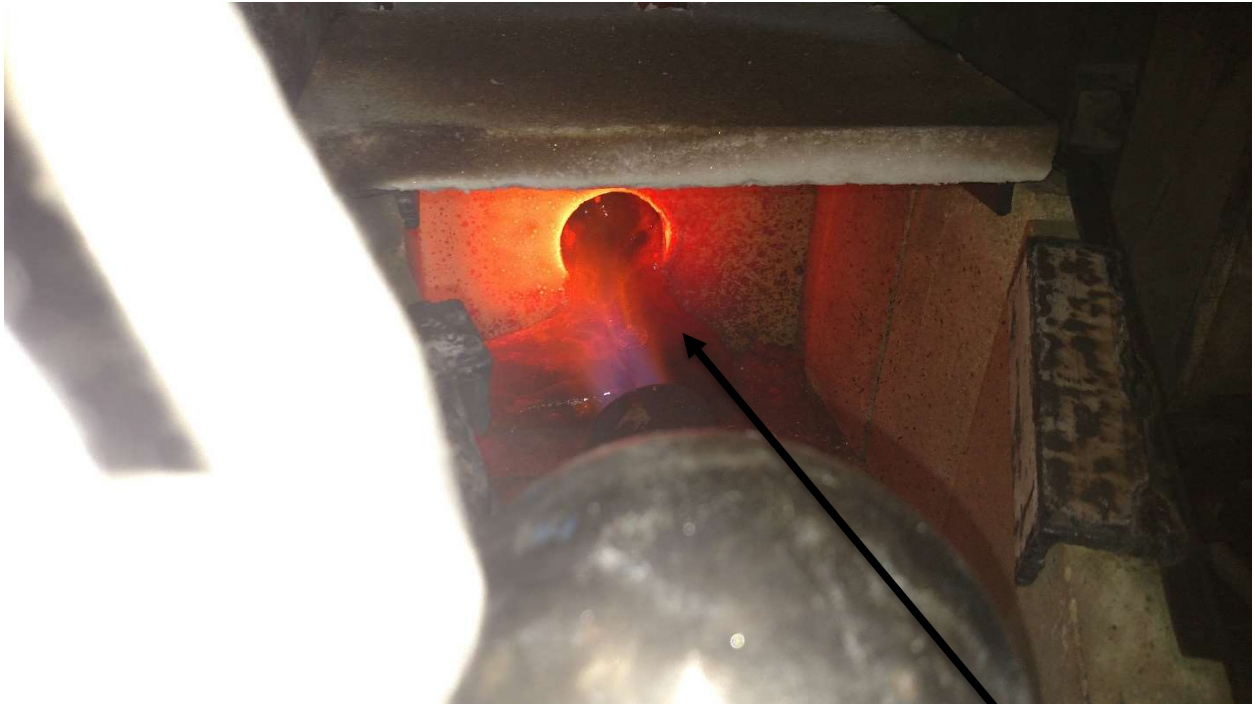
Glass oozing out was before the drain was called off. No lancing was done after this picture, due to the void that was created in the refractory material. Shortly after this picture, the drain was called off.

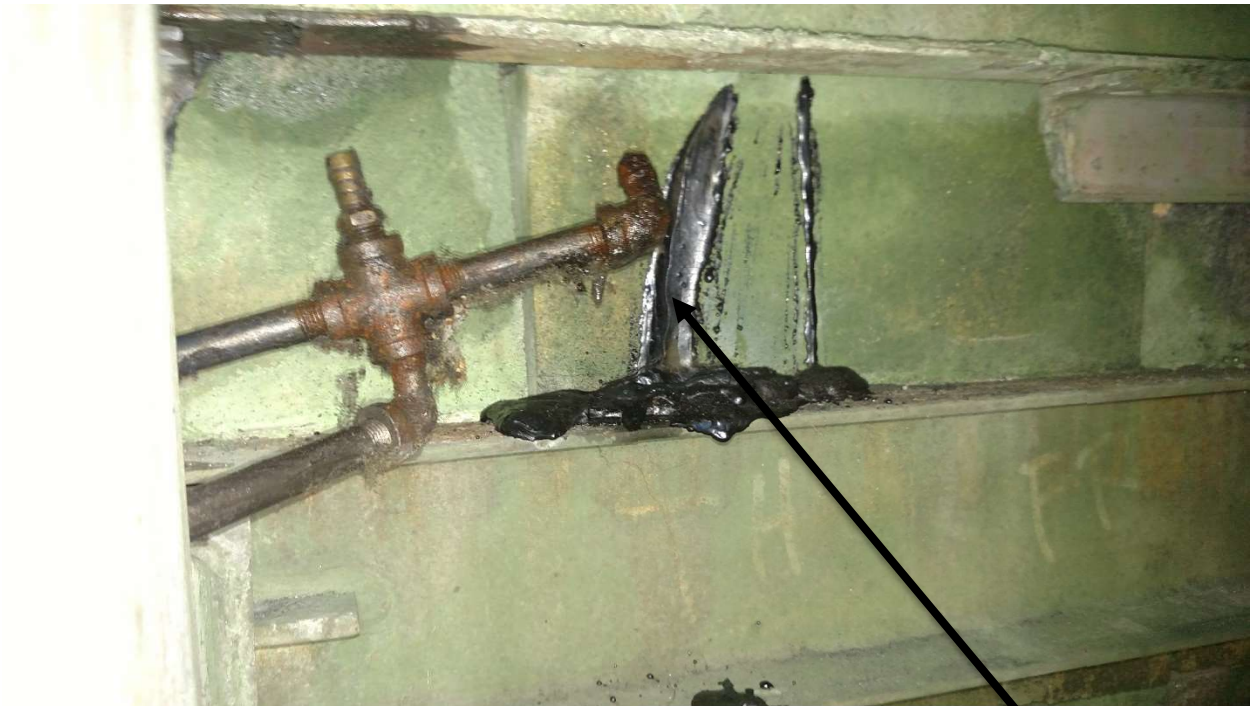
Mr. Kelton was the one to attempt the lancing. Upon the attempt to use a lance, molten metal from the lance pipe was observed to have run thru the furnace sidewall and ran out under the Hotwork taphole and trough. The presence of this metal indicated that the sidewall refractory was deteriorated/compromised. If a flow of hot molten glass could be established, it had a path to an uncontrolled leak versus being controlled in the taphole and trough. This void created a safety concern with the potential for an uncontrolled glass leak if hot glass flow could be established. Lancing was discontinued for fear of creating a catastrophic situation by further compromising the sidewall refractory.

Metal that had leaked out and under the Hotwork trough, through a void that was created in the refractory due to OXY lancing. All lancing was aborted after this point. Due to the concern of the void. If glass entered the void, there would be no way of controlling the leak. This is a major safety concern for the Hotwork crew on site as well as the safety of the plant.

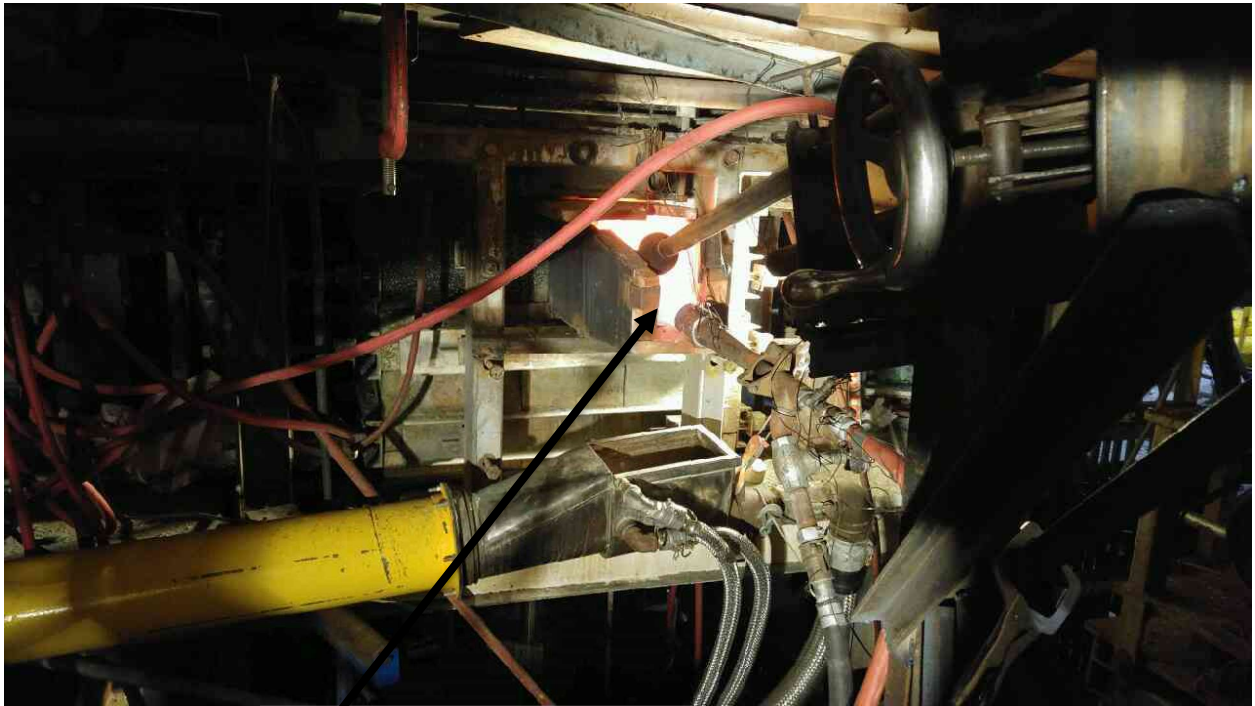
Mr. Kelton was asked if the drain site could be relocated to which he replied, “it would just cool the entire throat due to the drill water and killing all the power while we drill. It wouldn't gain us anything. It was hot on the outside due to us using our burner but cold behind the hole. We did everything we could.” Mr. Kelton was trying to convey that the general glass temperature in the furnace was too low. At this tapsite, with the advantage of an overnight soak and external burners, the glass was still too cold. Starting over at a new position would require interrupting the electric heating further lowering general glass temperatures. The drill site would be locally cooled from the drill water. Client Plant's ability to heat the entire furnace up to a higher temperature was limited due to the poor condition of the furnace.

Moving the drain site was also not an option due to the limited clearance in the area. Compared to past drains this one had more cooling water running on the bottom, resulting in a cooler bottom and cooler overall glass temps.

Redrilling in another location was not an option, due to the constraints. At the same time redrilling in the same location was not an option as well. This would only further cool the furnace, due to shutting off the power to drill. As well as introducing water into the throat area from the drill
