Did I jinx us? In the last Tech Note I pointed out all of the positive feedback that we had been getting from our clients. We had feedback survey forms that were all 10's and even specifically authored, unsolicited letters of praise about our Techs. All really good stuff.

Since that time, we have continued to receive some very positive feedback but we have had a couple projects where a client was not happy – and they made their feelings known in somewhat graphic detail. Of course, we have to discuss these situations and find a way to improve.

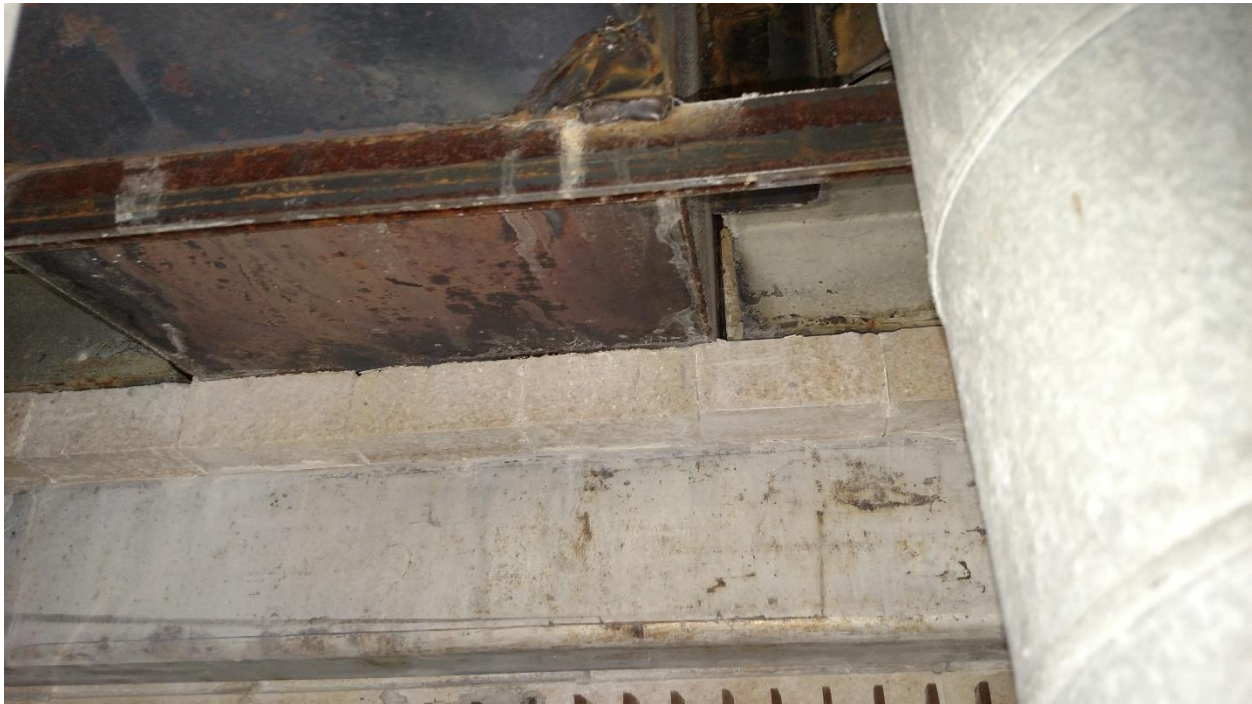
On the setup day, Kevin Kelton asked for information about where the furnace bottom was. An engineer from the plant supplied a drawing but he was unsure whether it accurately represented the actual furnace construction. Our client was the rebuild contractor and he did not participate in this discussion. We proceeded to set up based on our understanding of where the bottom was. This photo looks up at the bottom of the trough as installed.

We believed we were setup with the trough at the bottom of the sidewall block but, in fact, the bottom of the sidewall block was at the bottom of that course of brick.

- 1.) We need info from our client on where the bottom of the furnace is. They need to participate in the decision on the location of our hole. Sometimes the information may not be completely forthcoming or clear but if they agree that's where we should put it, it eliminates a lot of second guessing later.
- 2.) Whenever possible, we should get the bottom of the sidewall block exposed so that we can see it.
- 3.) Never teardown and/or leave site without checking with our contact.

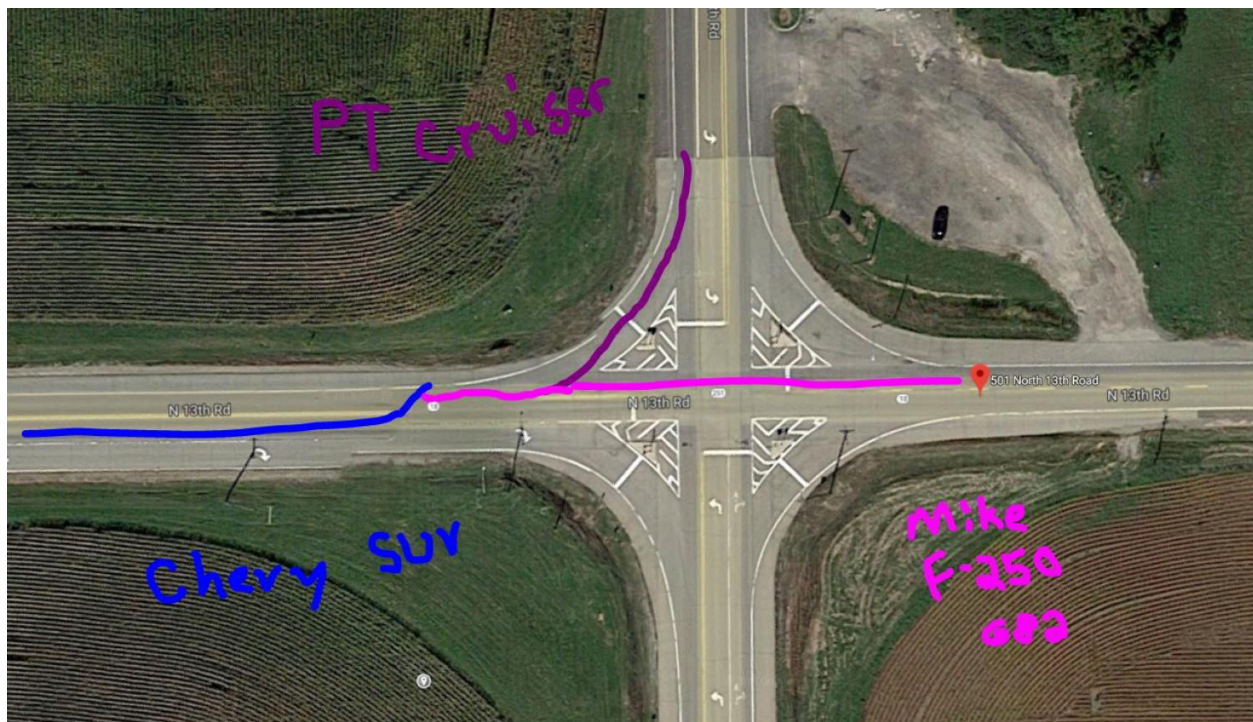
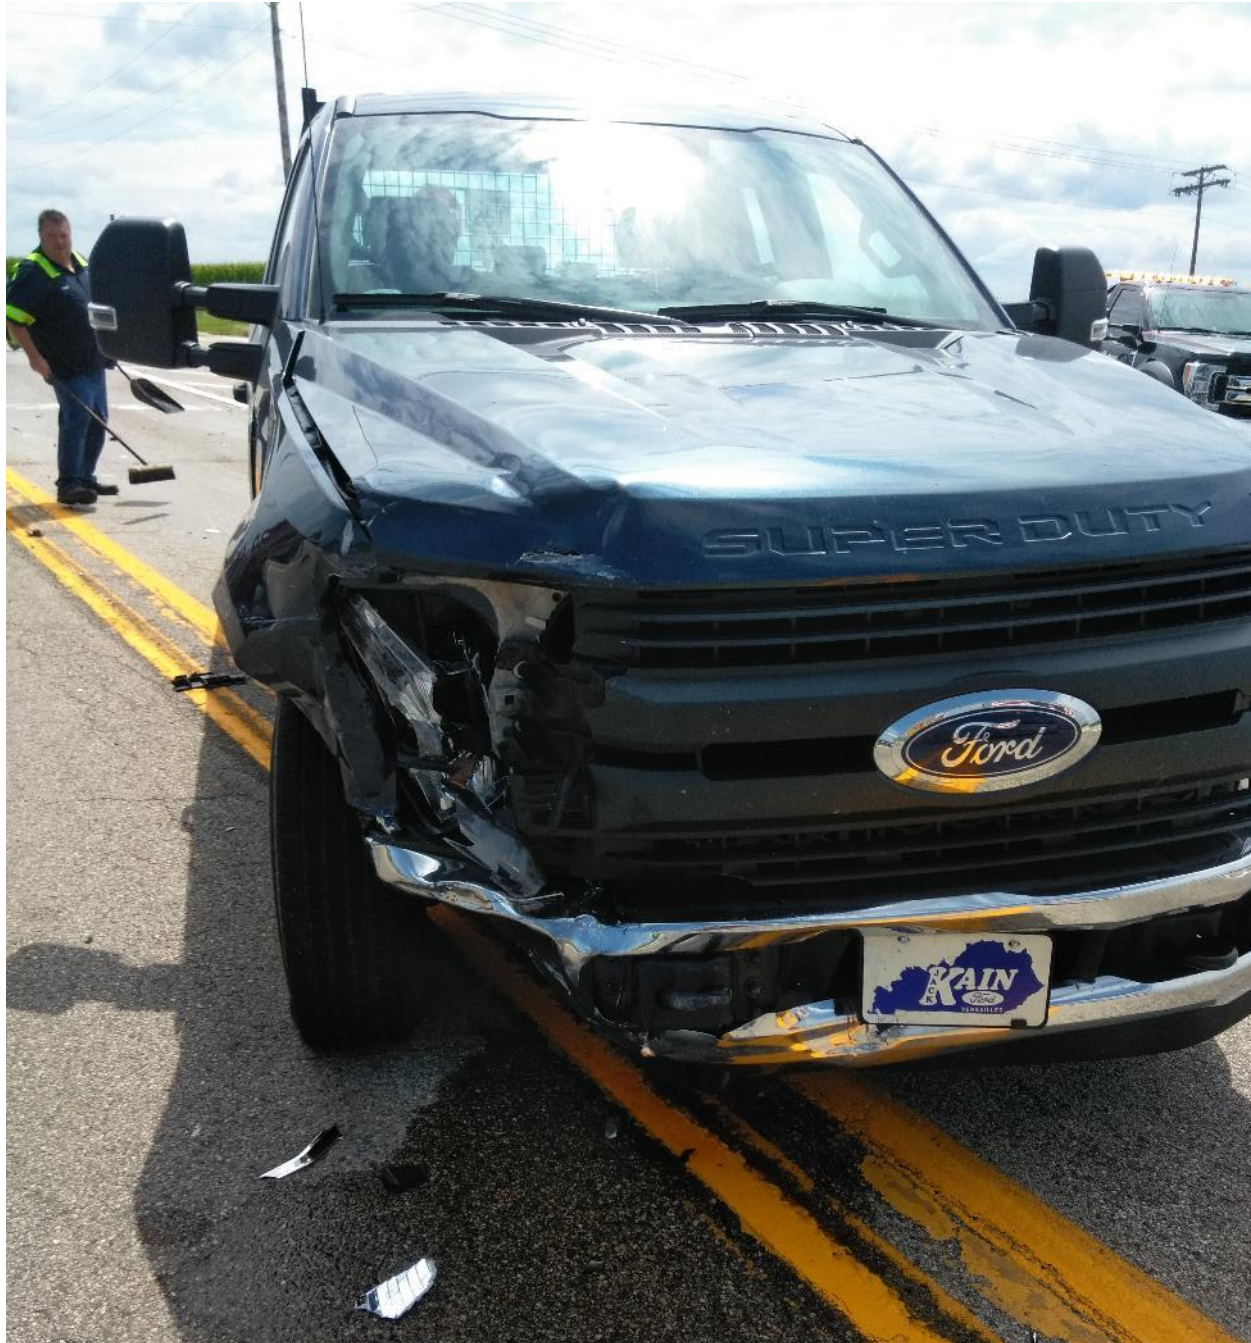
Meanwhile Mike Blythe is finishing up a night shift in Illinois. He goes to the hotel and gets 3 hours of sleep. He says he was awakened by an ambulance and couldn't get back to sleep. So he decides to head for home. He's not far from the hotel, getting close to the interstate, and he blows thru a four way stop intersection and hits a PT Cruiser on the other side as the cruiser is merging onto his road. The impact pushes Mike into the oncoming lane and a SUV swerves to miss him and gets hit by Mike on the rebound. Luckily, no one is seriously injured.

Mike says he had a sneezing fit and didn't see the 4-way stop. This is dead flat and straight Illinois – the intersection would be visible for a mile in advance. Whether it is sneezing fit, fatigue, cellphone distraction – it doesn't matter. We have to be in control of our vehicles. There is no excusable reason to blow thru a stop sign and have a wreck with the serious potential for injury like this one. I am so thankful that no one was seriously injured.

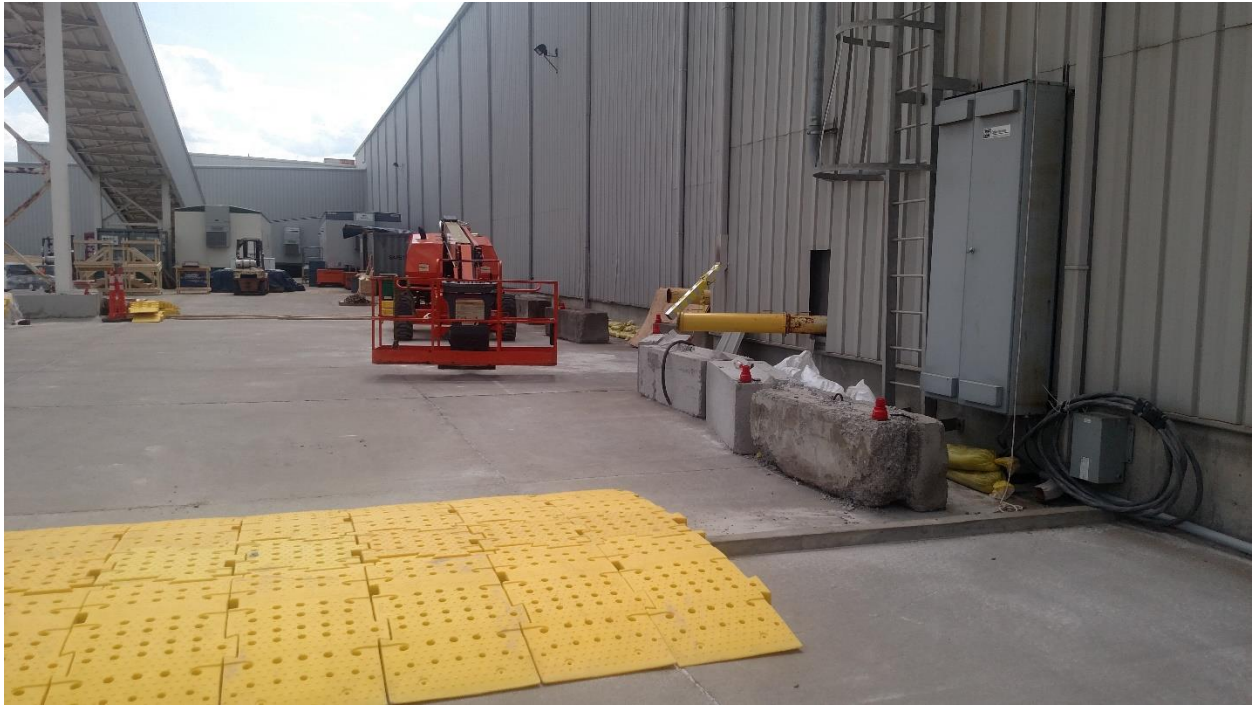
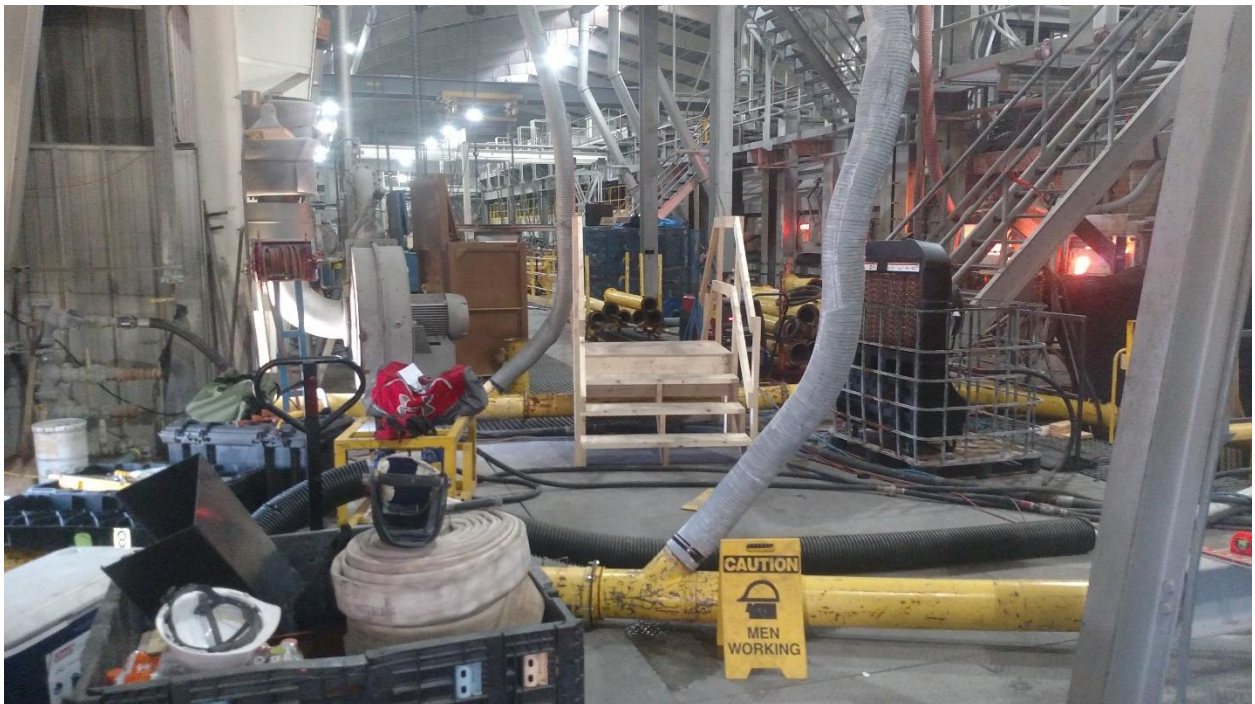
So next we had a double tap float drain. The drain pipe came out of the building low and the client wanted the glass deposited just outside. So the setup had the two pipes terminating just outside the sheeting line and the only vent was a round vent inside the building. The round vent had duct going up

20' or so. One of the runs had the duct tied to a handrail, the other one had the duct standing unsupported.

During the drain, visibility was poor on the cullet pad. The front end loader bumped or blocked the pipe several times. At one point, the loader got in the flow of glass and water and got red hot glass on a hydraulic hose. It burned thru the hose, released hydraulic oil, and ignited. The cab was engulfed in

flames and the operator bailed out. He got burned on his arm and a major accident investigation ensued. Some changes were made to improve traffic at the pipe end.

Sometime later, the loader blocked the end of the pipe backing glass and water up in it. It went up the duct inside the building and the weight of the water in the duct caused it to fall over to where it was pointing at Mike Gerald who was manning the ball on his first shift after training. Mike got the ball shut off, got out of the way but he had been sprayed with water. He didn't think he was injured but over time he learned that he had blisters on both his arm and his leg. He received first aid treatment and completed his shift. Hotwork made the decision to relieve him from the jobsite but the client was very concerned that a second accident/incident had occurred due to the same root cause – heavy equipment operation in near zero visibility conditions.

- 1.) A rectangular vent outside the building is necessary. It is the “fail safe” in the case of blockage and the area around it should be restricted access. Note: If we needed to move the cullet deposition point in order to get a rectangular vent in, so be it. It is particularly important at this client because on all of their furnaces, the pipe comes out low (in harm’s way).
- 2.) The pipe end should be terminated short of the jersey barrier. That way the glass and water will shoot over it and the pipe end has a physical barrier protecting it.
