Incident Investigation Report

- 11. Attachments: (Facility Report/Photographs/Medical report)
 - a. Coke Drum Incident (Open Air Thermocouples)
 - b. Vessel [B] Incident
 - c. Coke Drum Schematic
 - d. Hotwork Equipment Layout Sketch
 - e. Burner Damage Photos (1 & 2)

Vessel [B] Incident

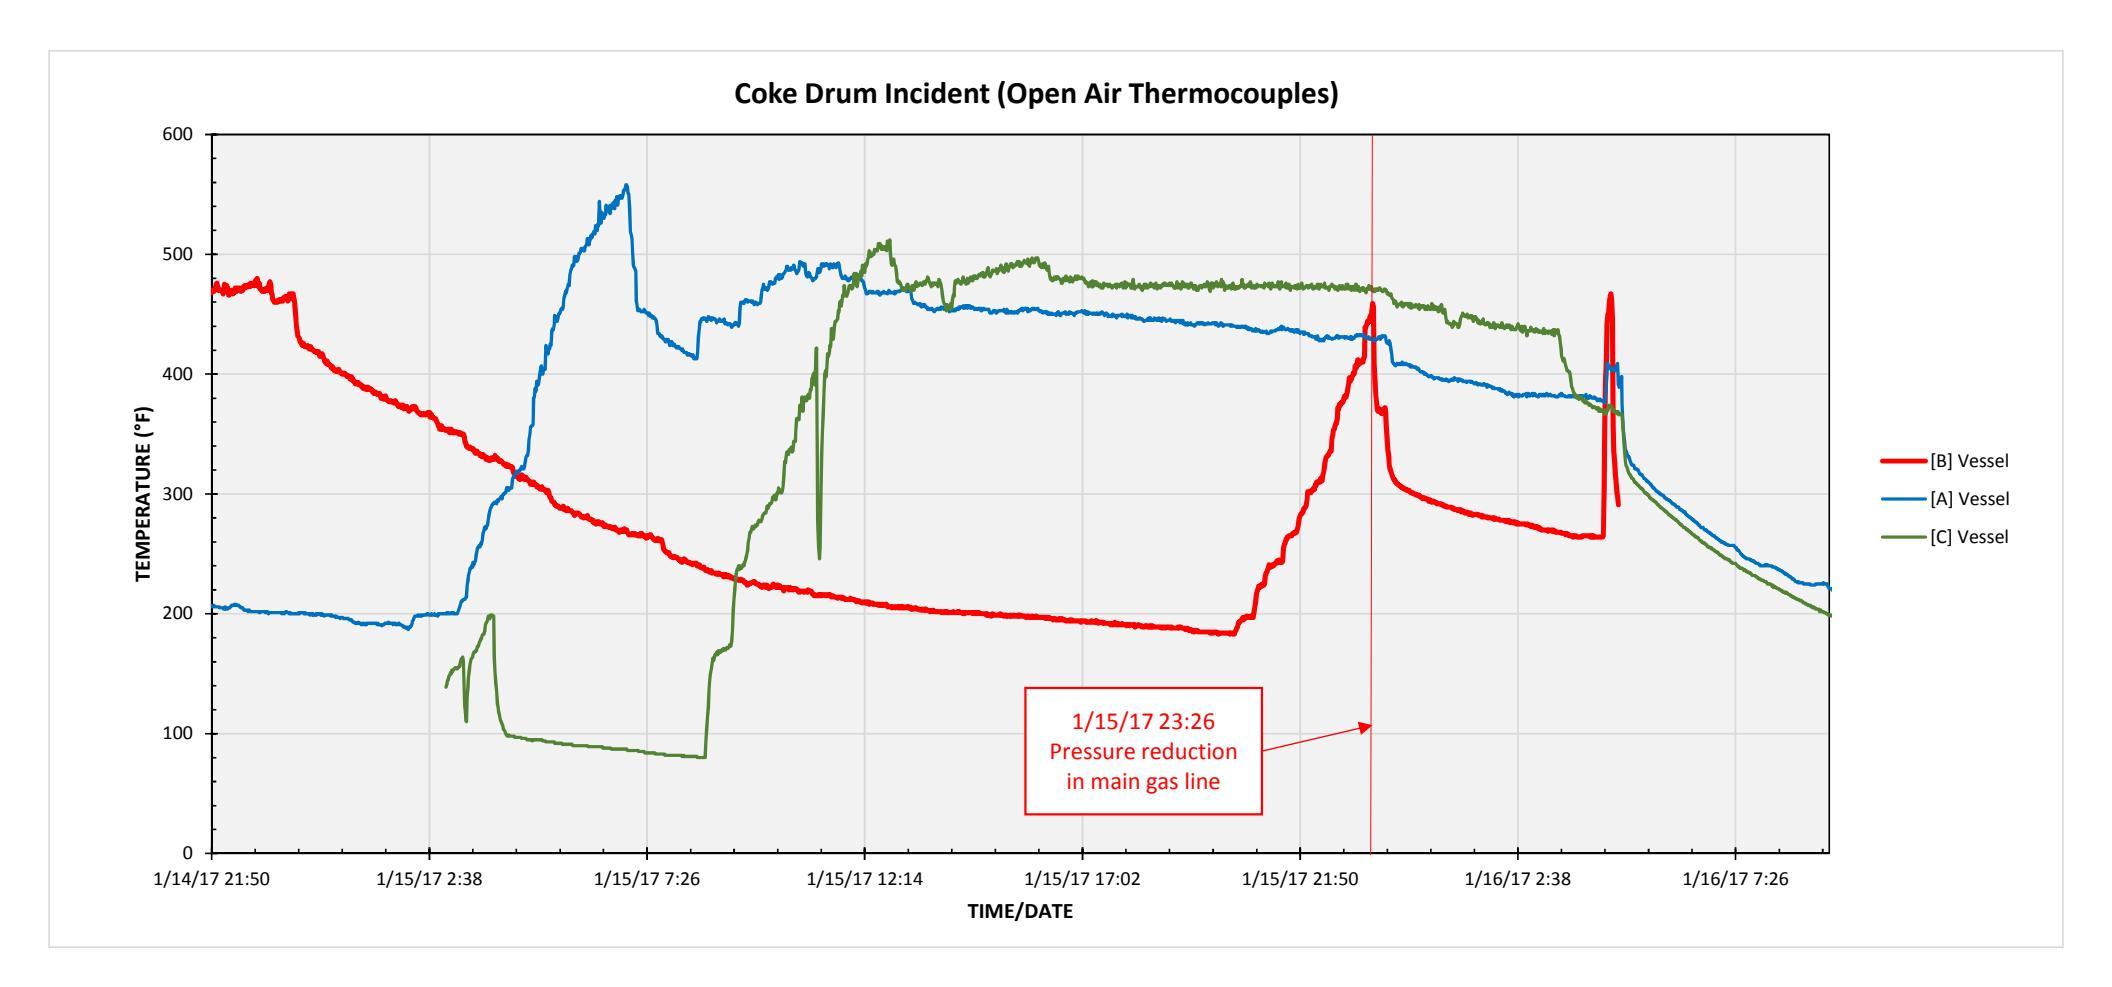
Attachment A

Attached is a chart depicting the air thermocouple measurements on all three vessels that were under fire in the time period of the incident. Vessel [A] was in an extended hold at the time of the pressure loss. Technicians reported low burner output (barely on main) in order to sustain the hold temperature. Vessel [C] was also in an extended hold at the time of the pressure loss and Technicians reported that it was also on low fire (pilot only). Vessel [B] was attempting to ramp from ambient to skin temperatures of 300°F. In order

to do this temperature ramping of the large volume of air in the vessel and the large mass of metal, this burner was firing at a much higher rate (burner on boost). At the time of the pressure loss, although air thermocouples in all three vessels were in a similar range, the firing condition of the three burners were quite different. With low flow conditions on two vessels, the loss of pressure had minimal impact on the air TCs. The metal in those vessels was at close to the same temperature as the air in the vessel. On [B], while ramping, the burner flame temperature was significantly hotter than the air TC and the metal was lagging behind the air. When loss of pressure caused a reduction in flow to this burner, the flame temperature diminished and the colder metal pulled the air temperature down to a greater degree than in the other two vessels. Attempts were made to offset the temperature declines by opening [B] gas valves and by taking gas off [A] and [C] in order to direct gas to [B]. It is apparent from the air TC reading that the flame temperature of the burner diminished significantly and the colder metal temperatures contributed to the air temperature declining.

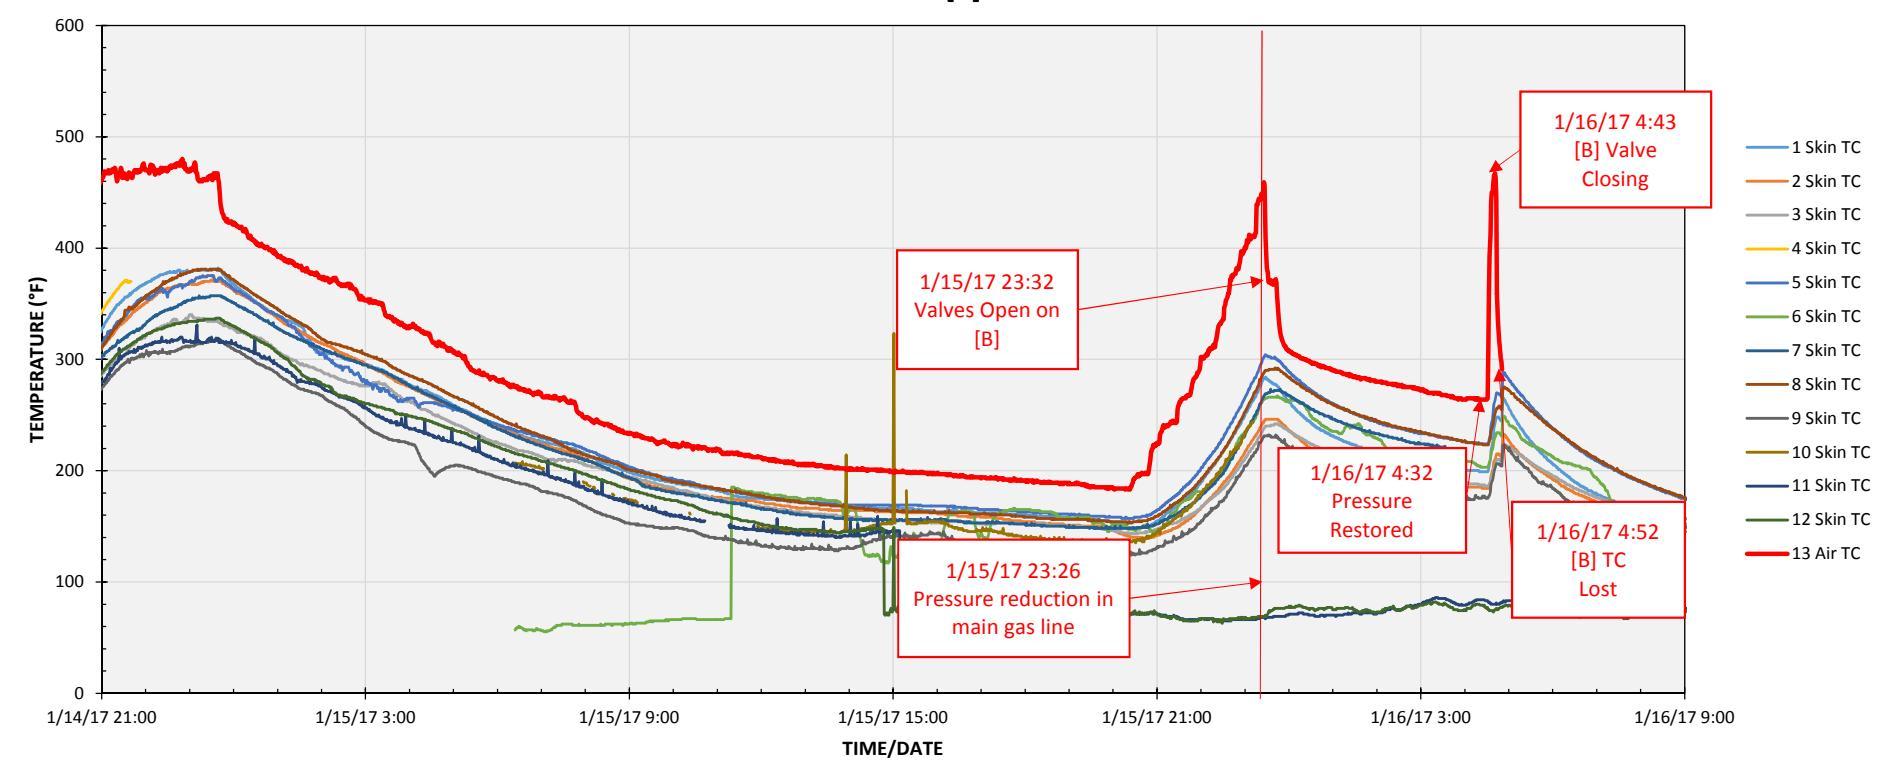
Hotwork believes that a low gas pressure event initiated at about 23:26 on 1/15. This event happened during a temperature ramp on vessel [B] and the burner control was already set for a fairly high flame temperature. When pressure was lost, the crew attempted to compensate by adjusting the regulator and the gas control valves to get more flow to the burner. The gas supply situation was inadequate to achieve target temperatures and both gas and metal temperatures declined. Attempts to direct more flow to vessel [B] resulted in temporary halt in the temperature decline but after 10 minutes, the decline continued. The low pressure event continued for over four hours. At about 4:30 on 1/16 a pressure restore event happened. This caused a rapid rise in the air TC in vessel [B] as both the regulator and the gas control valves had been adjusted for maximum flow at the lower pressure. In less than 15 minutes, the air TC in vessel [B] climbed 181°F which indicates a significantly higher flame temperature at the burner. Hotwork suspects that the burner went reducing during this period. Adjustments were made to the regulator and control valves in order to reduce the flame temperature. It

appears that these adjustments were accomplished at about 4:43. The flame was then burning in an excess air mode and combustion air was reintroduced to the vessel along with products of combustion. At 4:52, the air thermocouple in vessel [B] was destroyed and ceased to report to the recorder.

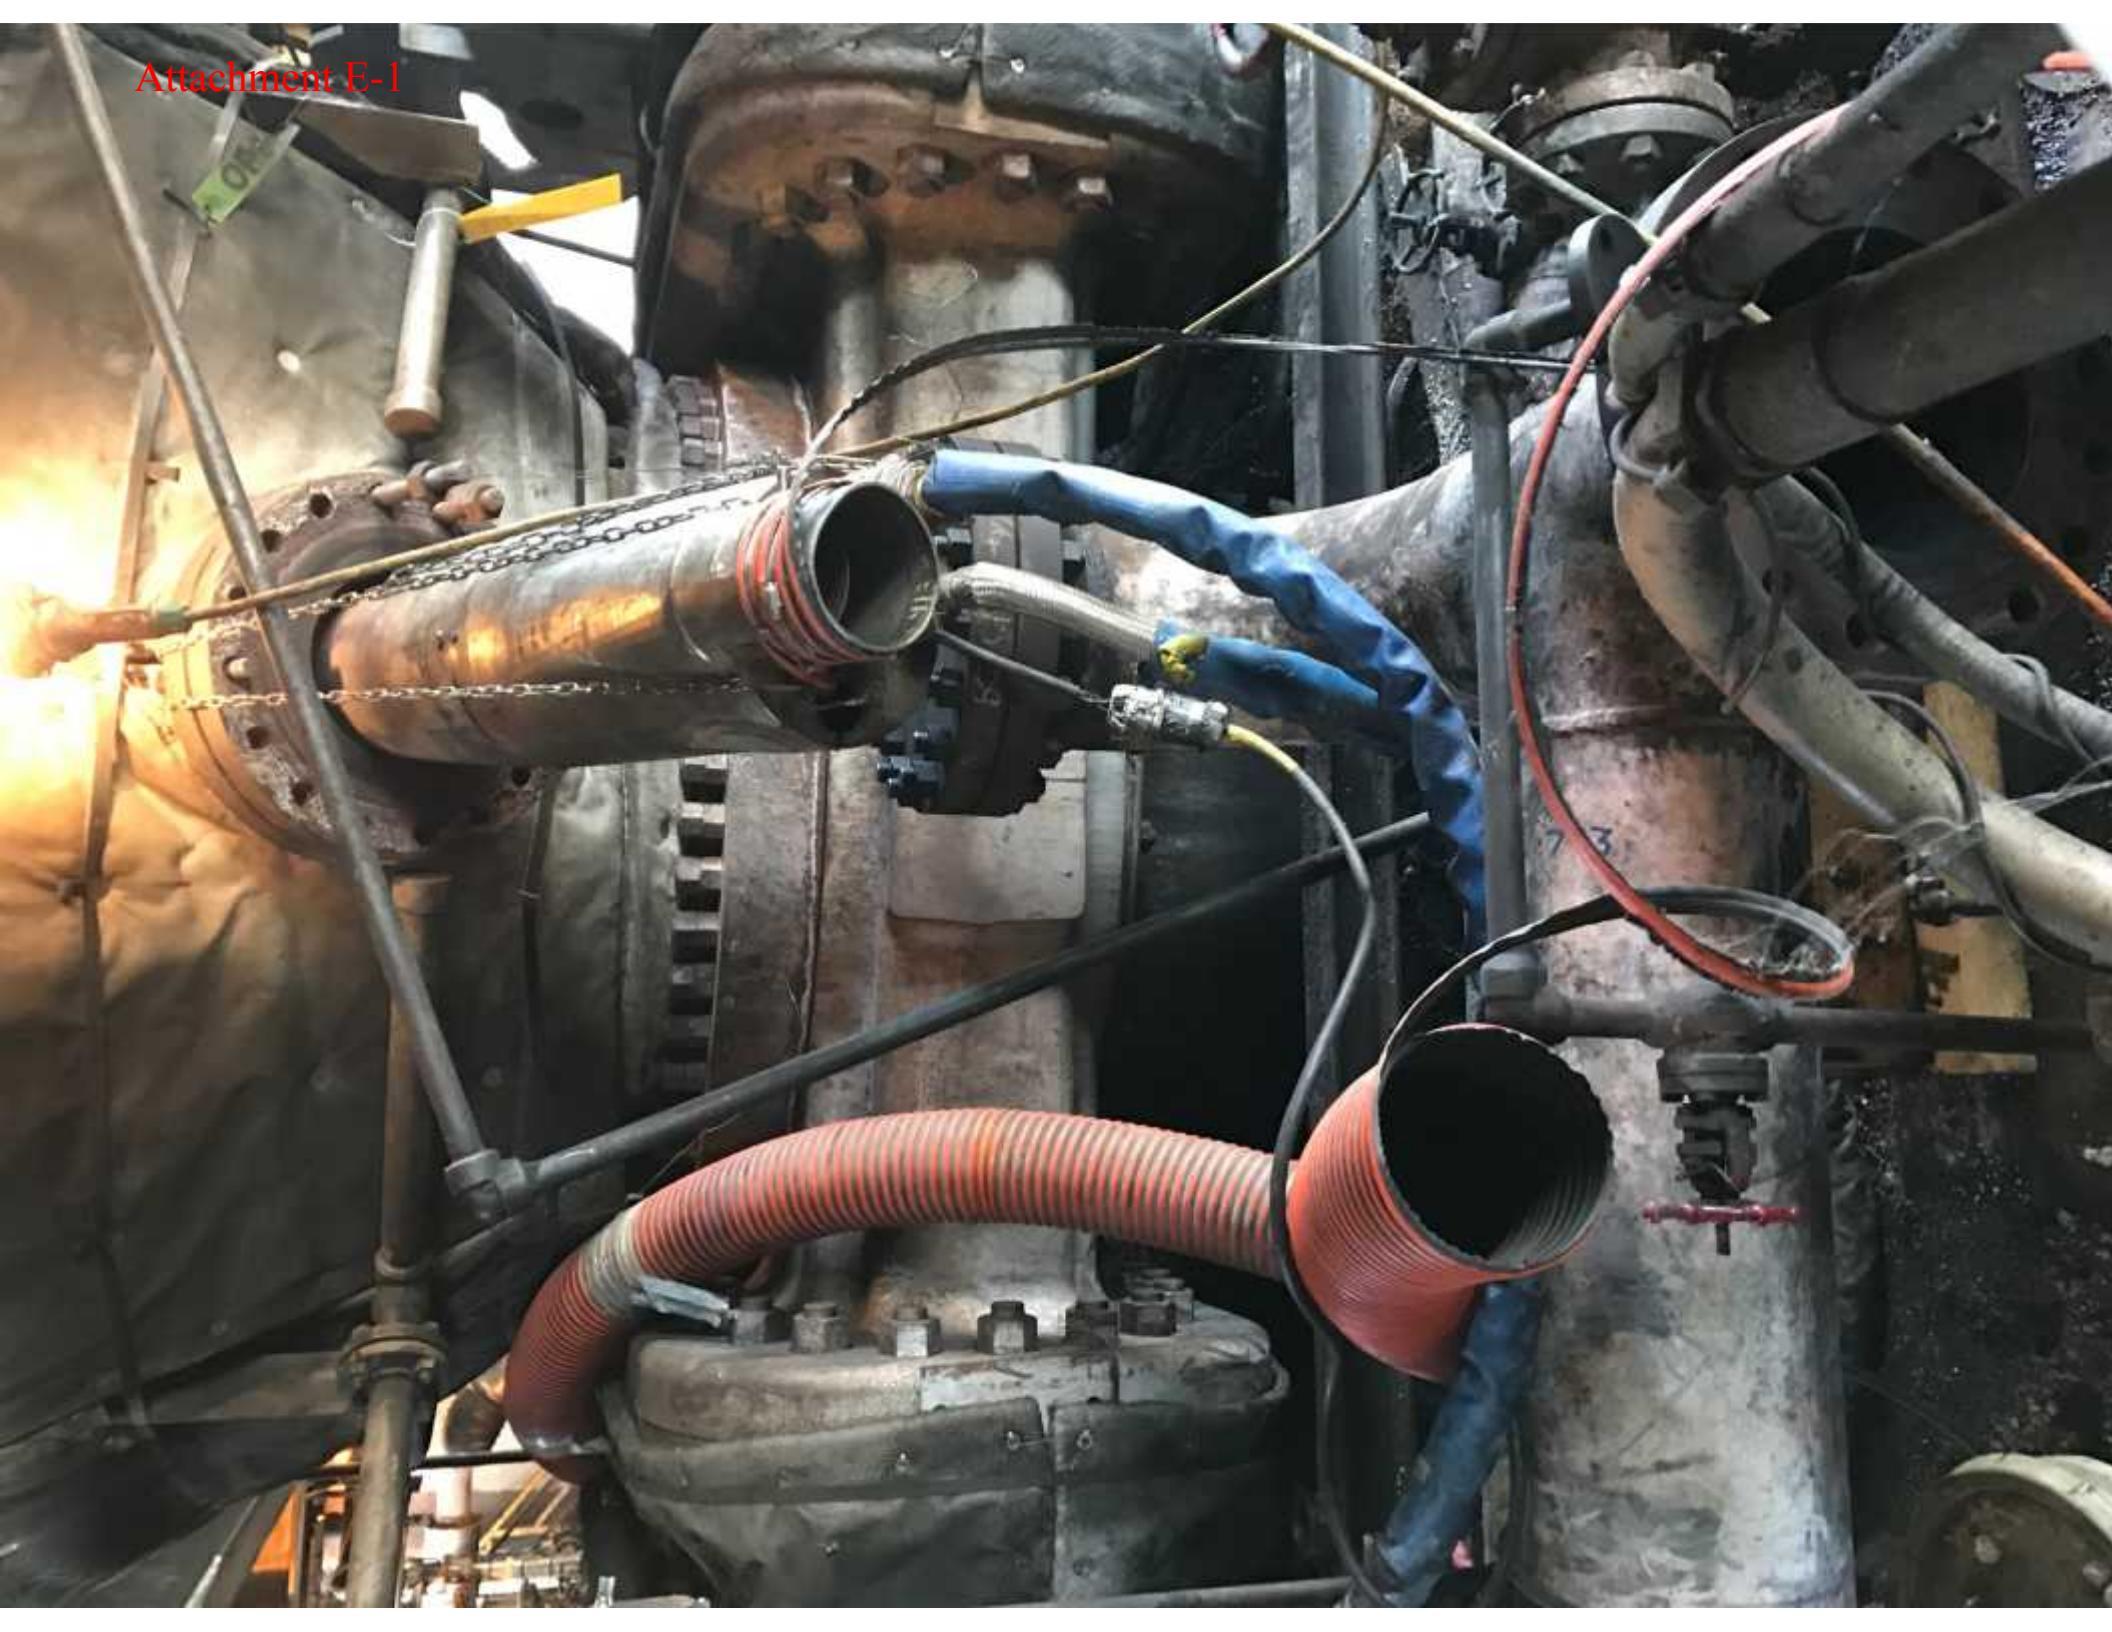
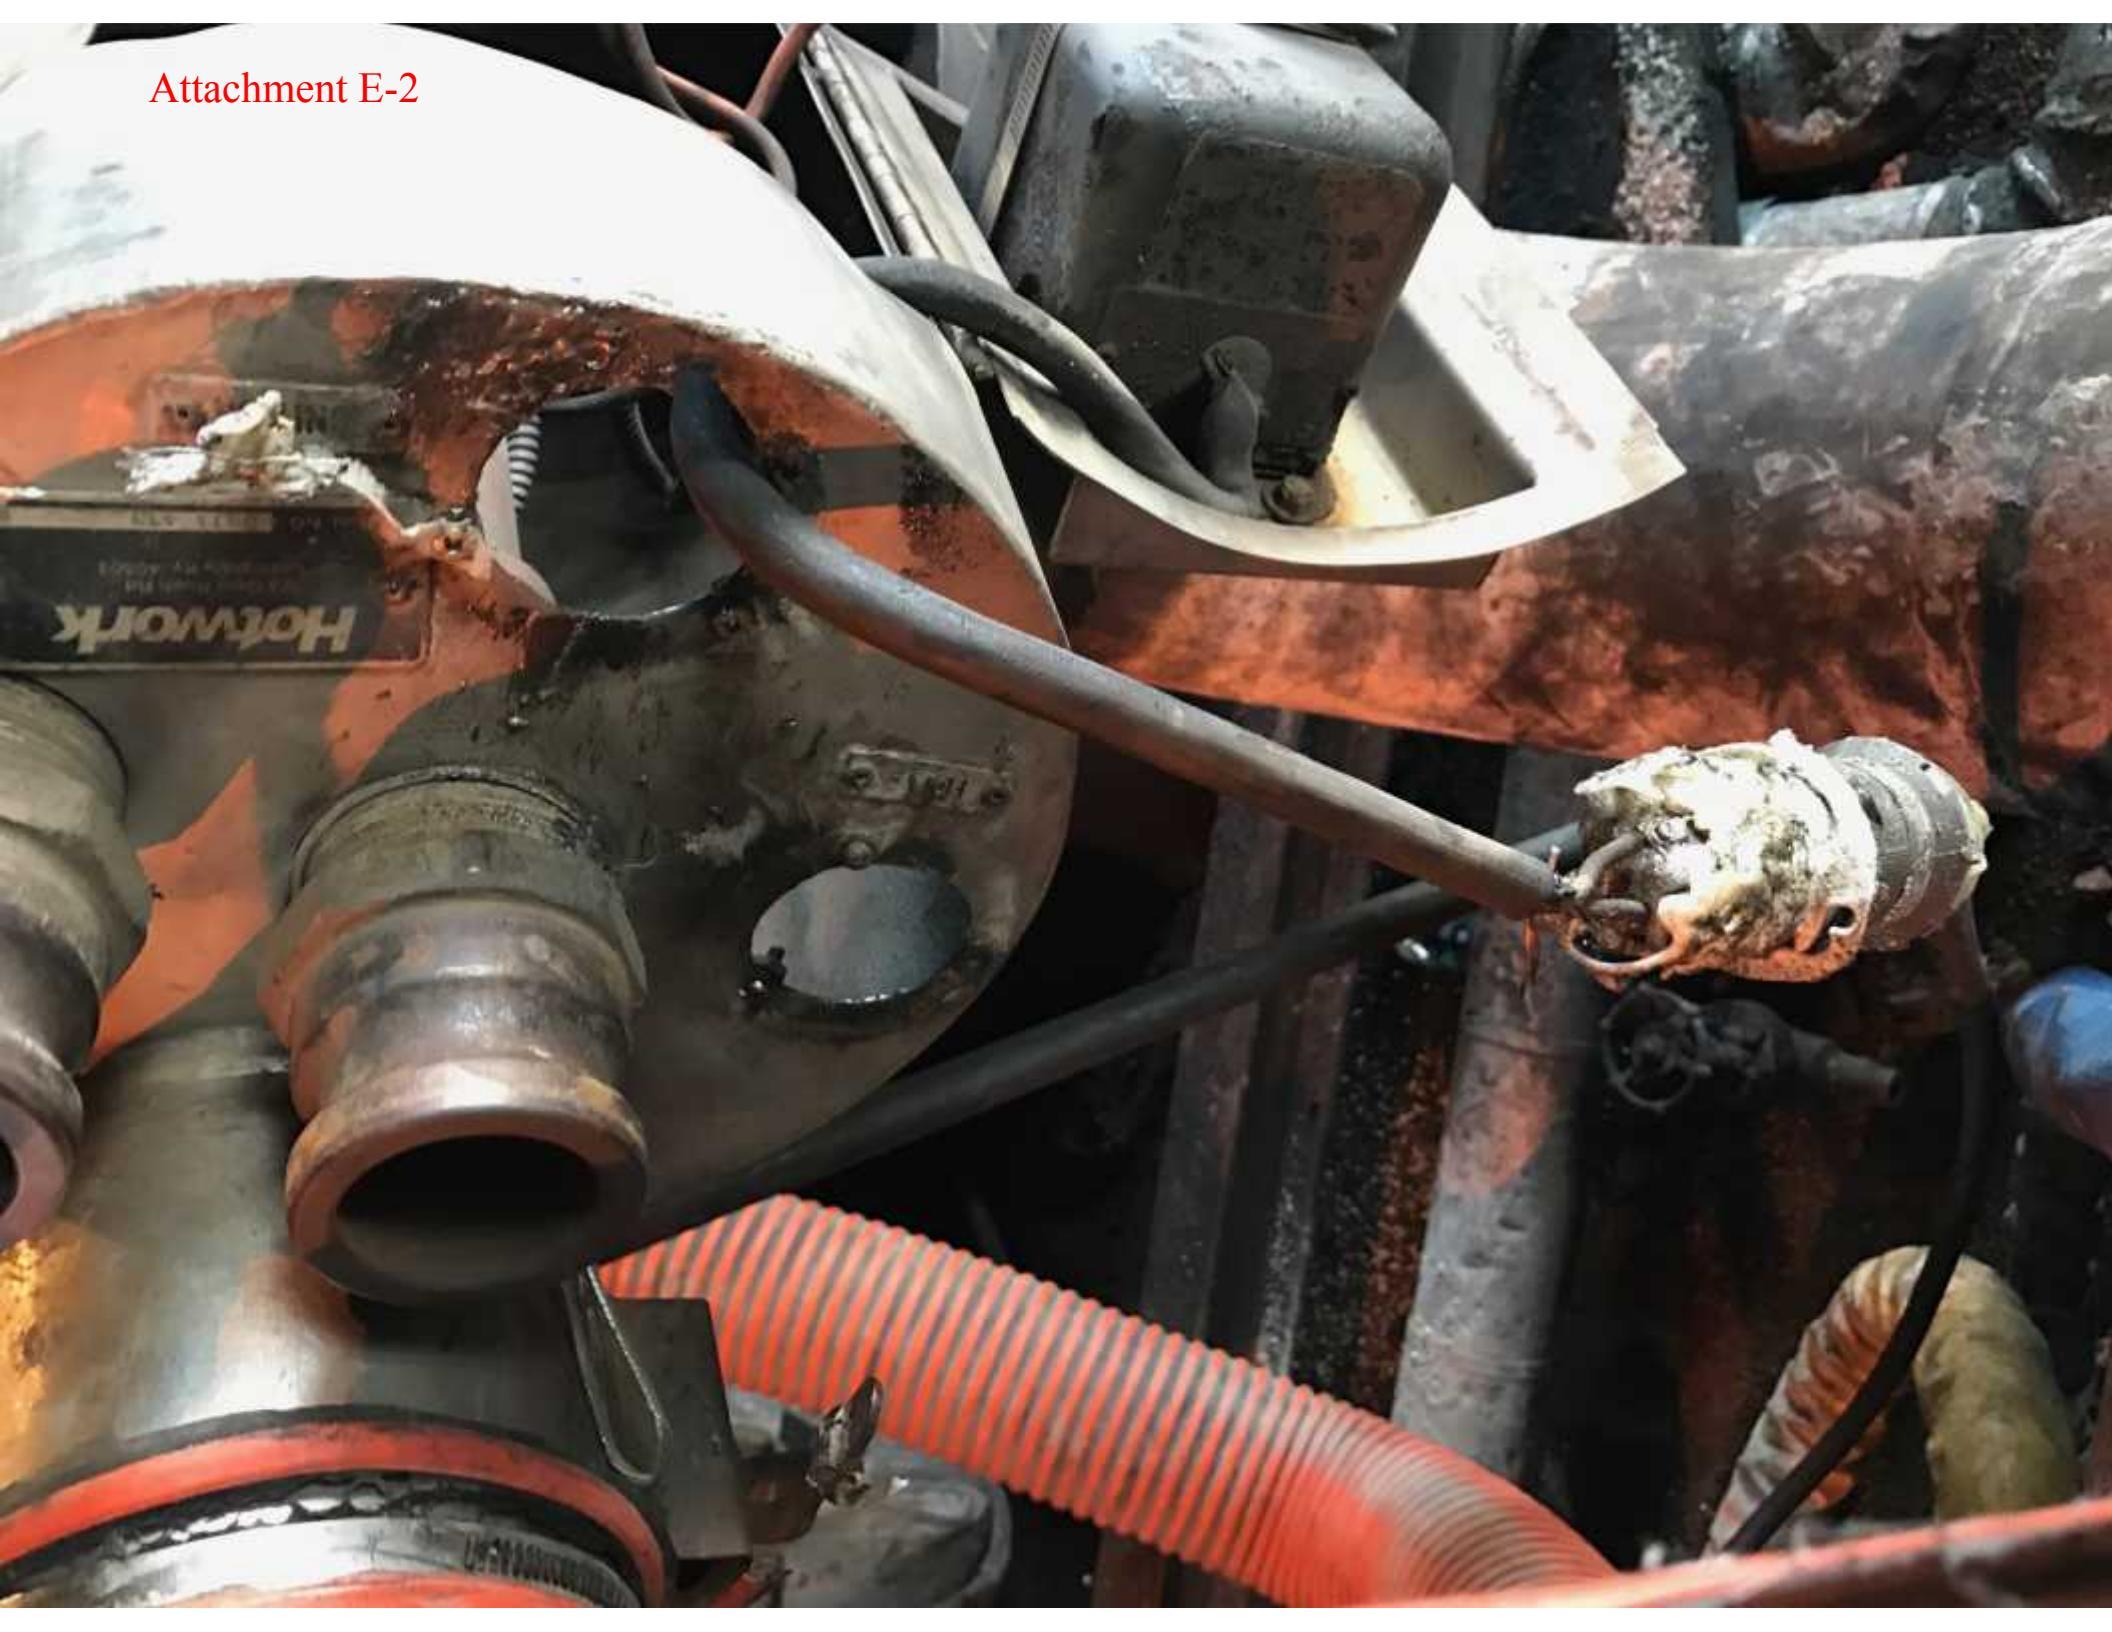
With the burner firing at an alarming rate and the temperature spiking dramatically upwards, [Tech #1] spent 5-10 minutes making adjustments to the Hotwork regulator and A/C box valves in an attempt to get the temperature back under control by lowering the gas pressure and throttling the control valves. After 10 minutes, the flow had been successfully lowered, but it is suspected that an amount of unburned gas had entered the vessel in the minutes leading up to this. When the gas being introduced was lowered to the point that the combustion air being forced into the unit created the correct gas to air ratio for combustion, a flash occurred when the mix of unburned gas and air ignited inside the vessel, away from the burner. This flash was forceful enough to blow the TC hanging 45' down into the vessel back up to, and out of, the top exhaust stack. At that point, the TC ceased to provide values to the recorder. It also caused hot gas blowback into the Hotwork burner, melting the internals. No flame was observed coming out of the vessel by the plant fire watch, only a "whoosh" sound was heard.

- 7. Remedial Action: Gas and burners shut down and project suspended until client facility completed incident investigation.
- 8. Procedural Change:
 - a. In concert with **and and and**, additional flow and pressure monitoring has been implemented for each individual burner. Procedures were established in the event of excursions on any of the monitored values.
 - b. Hotwork Technicians were instructed to maintain last adjustments in the event of a pressure loss and to work with the client to achieve pressure restore.
