We are quite busy now and the majority of our projects are being executed successfully. Unfortunately we had two very serious incidents in the same glass plant in the last few weeks. Everyone should already be aware of these events but I will go over them again due to the seriousness of the events.

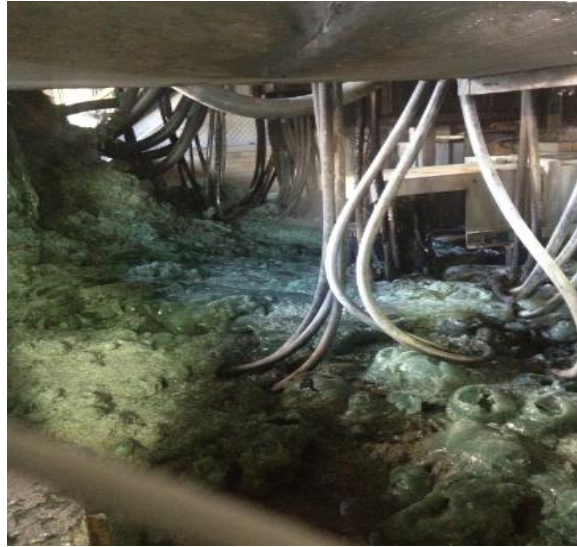
I previously sent out a notice on the glass drain issue. Due to concerns about electrical grounding expressed by the client, Hotwork removed some of the supports for the trough. When drilling the hole, hot glass was encountered and the drill hung up while removing it. While struggling with the drill, the trough moved due to inadequate support. This allowed glass to start to flow between the covertile and the furnace block. The glass continued to leak until a water lance was inserted inside the furnace. About 20 tons of glass leaked onto electrode cables and several hundred tons of glass was left in the furnace and had to be mined. The client incurred extra costs and an extension of their planned outage. We are working with them to resolve the claim due to the glass leak. Lesson learned on this one – the trough and cover tile are critical components in the glass shutoff system. We have to be sure that we have adequately secured our equipment so that they can perform the intended function. The crew did a great job responding to a terrible situation but we really don't want to become expert at fighting glass leaks. Let's be expert at preventing them.

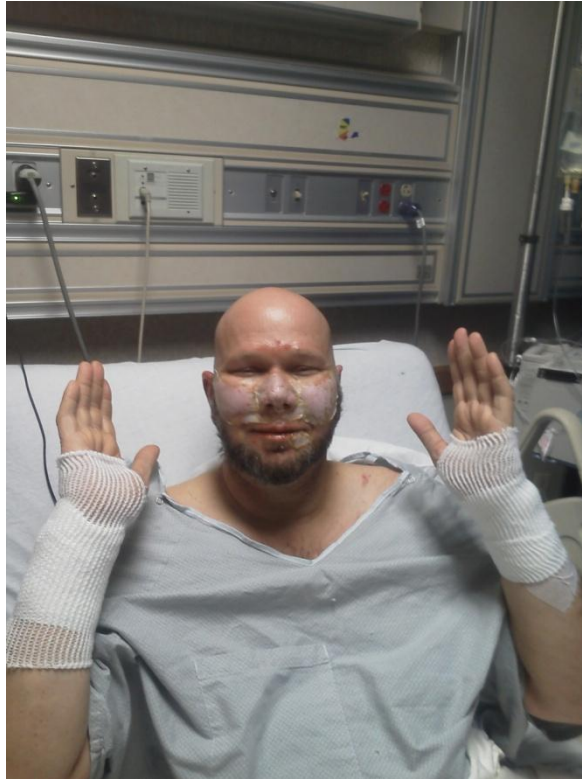
On the heatup at the same furnace, the plant was ready to takeover the forehearth so the Hotwork burners were isolated at the client valve and burned off until the burner went out. The gas hose was broken at the client supply which was then capped. Shift change occurred and the night shift was to tear down the disconnected forehearth equipment while continuing to operate the burners in the melter and riser. There was no time pressure or reason to rush. Karl Burger admits that he made a mental error when he went to the client supply valve for the riser burner. Without checking valve position or tracing where the hose went, Karl removed wire and popped open the QD encountering gas. He called to Nathan Perry to shut off the main gas while he tried to reconnect the fitting. Karl could not shut off the gas locally because there was no handle on the valve. While trying to reattach the fitting, the gas cloud was ignited by the hot forehearth. Karl says that he dropped to the ground to get out of the fireball. Nathan ran over 100 paces to the main supply valve and found that it did not have a handle. He located the handle behind a column, got it on the valve, and shut off the gas flow to the furnace. Karl had burns on his face and his wrists. His safety equipment was not damaged and he was not burned anywhere where his skin had been covered. Arrangements were made to get Karl medical attention and the process of re-lighting the melter and riser burners was begun. Karl ended up with 2nd degree burns to his cheeks, nose, ears and wrists. He was transferred to a burn unit where he received skin grafts. He is home and says that he is recovering well.

- 1.) Breaking a fuel line is a hugely critical task. It should never be done casually or recklessly. Karl made a mistake in that he thought he was dealing with previously shut down equipment – but that equipment had been shutdown and isolated properly. Somehow he got to thinking that a

live connected gas line was already shutdown. When he approached that connection to break it, he did not think to even check the position of the supply valve at the connection point. He didn't trace the hose and check the pressure gauge in the AC box. He just removed the wires and popped the ears on the QD. ***It is a huge concern to me that anyone working at Hotwork could be this casual about breaking a fuel line.*** This is one of the most safety critical tasks that we perform. No one should ever break a fuel line without stopping, thinking, and double checking. ***If nothing else, it is critically important that everyone learn this from Karl's mistake – never break a fuel connection until you have personally verified the fuel isolation.***

- 2.) The magnitude of this event would have been significantly reduced if there was a handle on the valve at the connection point. When Karl heard gas, he could have just turned it off. When an emergency happens, it is too late to be searching for a valve handle. Fuel isolation valves are critical emergency/safety equipment. If the handle is missing, a safety device has been disabled. The time to address the issue is at setup. Clients often remove valve handles to prevent inadvertent opening of gas drops that are not used while in production. ***We have to insist that the safety devices (isolation valves) are made functional before we put them in service.***

- 3.) Nathan Perry is to be commended for; a.) knowing where the main shutoff valve was located and b.) immediately responding to Karl's shouts and getting to the valve as quickly as possible. Unfortunately, this valve also did not have a handle mounted which caused some delay in emergency response. Once again, the time to address a missing valve handle is at set up – not during an emergency. ***Every crew member must know the location of the main fuel isolation valve and know how they will operate it in the event of an emergency.*** You never know when an emergency may happen and you have to be prepared to act - when the emergency occurs, it is too late to trace lines and or find valve handles or wrenches.
