Incident Investigation Report

- 11. Attachments: (Facility Report/Photographs/Medical report)
 - a. Coke Drum Incident (Open Air Thermocouples)
 - b. Vessel [B] Incident
 - c. Coke Drum Schematic
 - d. Hotwork Equipment Layout Sketch
 - e. Burner Damage Photos (1 & 2)

Vessel [B] Incident

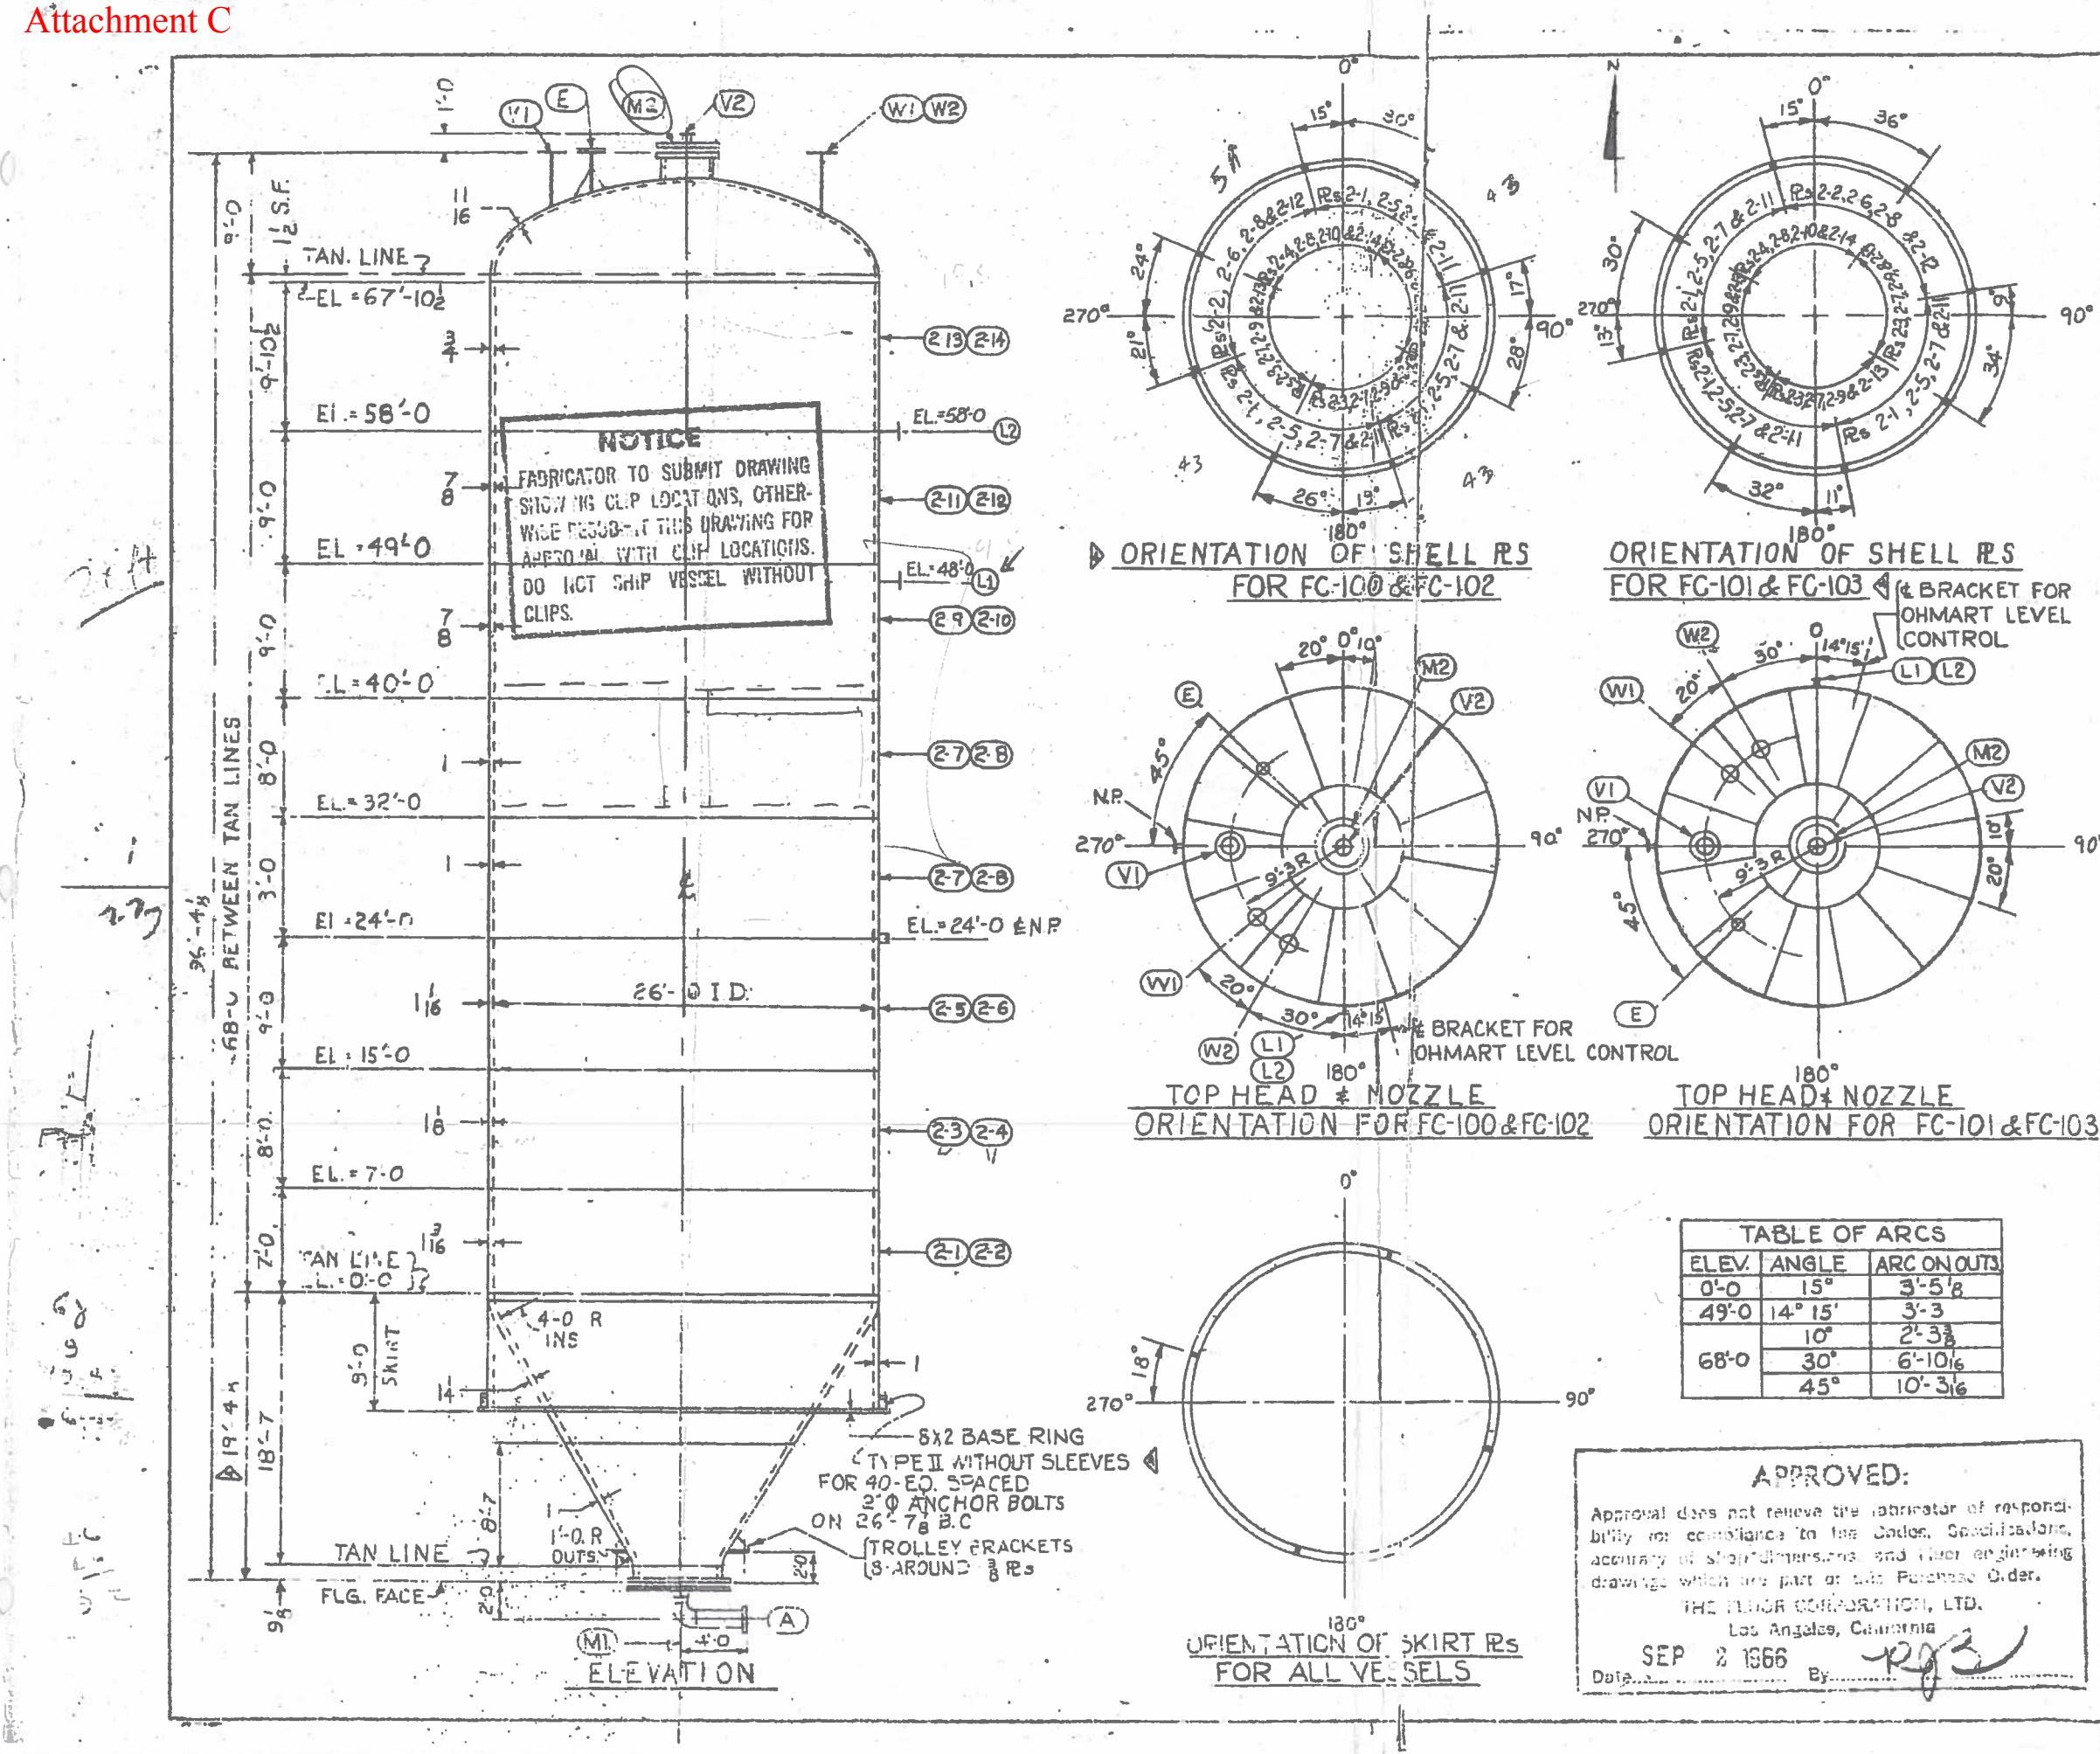
appears that these adjustments were accomplished at about 4:43. The flame was then burning in an excess air mode and combustion air was reintroduced to the vessel along with products of combustion. At 4:52, the air thermocouple in vessel [B] was destroyed and ceased to report to the recorder.
